Application of Statistical Process Control in Minimizing Defects in the Production of UPVC Sanitary Pipes

Gretchen T Cabunita, Consorcio S Namoco

Gretchen T Cabunita, Consorcio S Namoco. Application of Statistical Process Control in Minimizing Defects in the Production of UPVC Sanitary Pipes. Journal of Harbin Engineering University, 2024, 45 (7), pp.36-45. <hal-04676127>

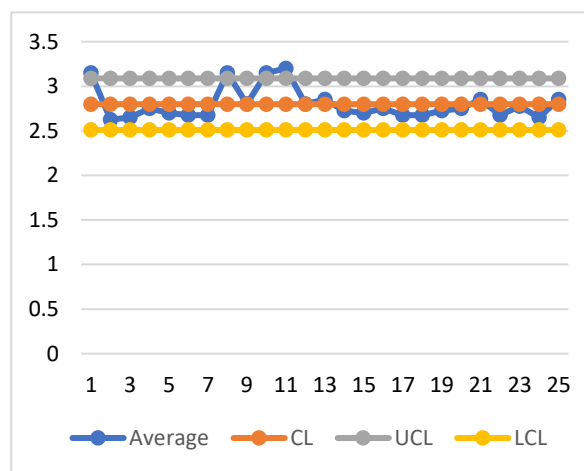
Figure 2. Resulting control x-bar chart of uPVC #2 thickness

Figure 2 shows the resulting control x-bar chart for the thickness of uPVC pipe size #2. It can be seen that sample number 1, 8, 10, and 11 were having an average of 3.15, 3.15, 3.15, and 3.2 respectively were found to be outside the upper control limit of 3.088. Having

samples that are outside the control limits provided an information that the process is not statistically controlled. There is a special cause of variation that should be identified because this makes the process not stable.

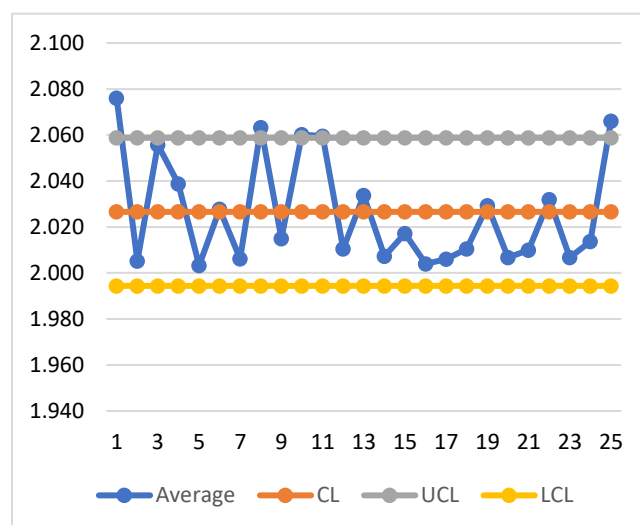
Figure 3. Resulting control x-bar chart of uPVC #2 weight

For the weight of uPVC sanitary pipe #2, Table 2 shows the x-bar chart. The unit of measurement for the weight is kilogram (kg). The mean of all sample means is 2.027 while the average range is 0.044. The upper control limit is set at 2.059 and the lower control limit is at 1.994. Figure 3 shows the resulting control x-bar chart for the weight of uPVC pipe size #2. It can be seen that sample number 1, 8, 10, 11, and 25 were having an average of 2.076, 2.063, 2.06, 2.06 and 2.066 respectively were found to be outside the upper control limit of 2.063. Having samples that are outside the control limits provided an information that the process

is not statistically controlled. There is a special cause of variation that should be identified because this makes the process not stable.

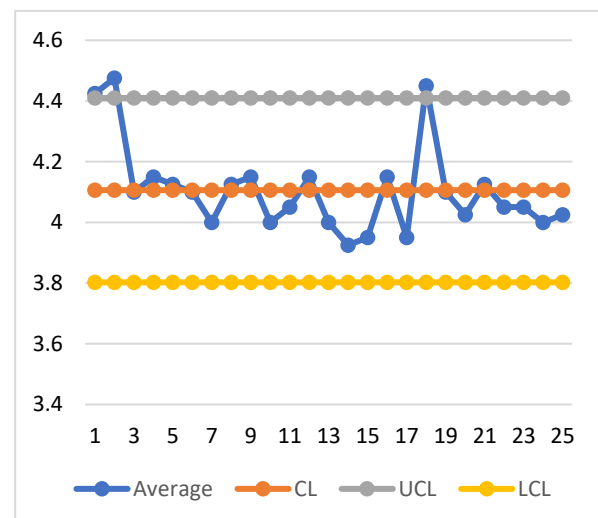
Figure 4. Resulting control x-bar chart of uPVC #4 thickness

Figure 4 shows the resulting control x-bar chart for the thickness of uPVC pipe size #4. It can be seen that sample number 1, 2, and 18 were having an average of 4.425, 4.475, and 4.45 respectively, were found to be

outside the upper control limit of 4.410. Having samples that are outside the control limits provided an information that the process is not statistically controlled. There is a special cause of variation that should be identified because this makes the process not stable.

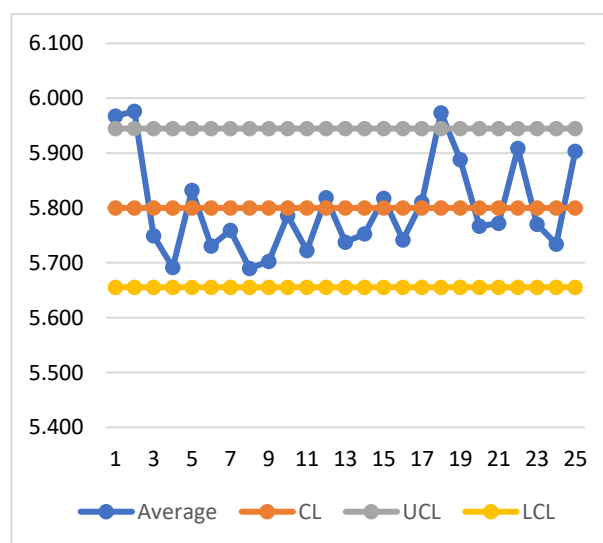
Figure 5. Resulting control x-bar chart of uPVC #4 weight

Figure 5 shows the resulting control x-bar chart for the weight of uPVC pipe size #4. There were three samples that were outside the control limits. These samples were 1 with an average weight of 5.968, sample number 2 with an average weight of 5.976 and

sample number 18 with an average of 5.973. Having samples that are outside the control limits provided an information that the process is not statistically controlled. There is a special cause of variation that should be identified because this makes the process not stable.

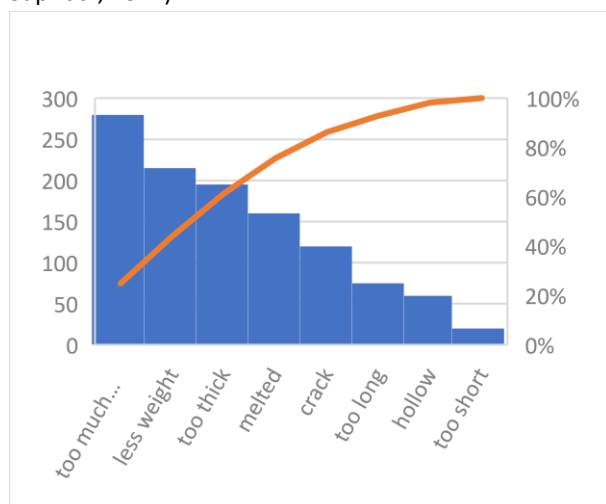
Figure 6. Pareto chart of the common defects of uPVC pipe

After implementing the control charts, the head of the operations was asked by the researcher on the usual defects they encountered during the production of these pipes. Using the pareto chart, Figure 6 shows the common defects and its frequency generated in a production cycle. Also, this chart will help explain in which of the common defects should be prioritized to address the encountered problems and improve customer satisfaction. Based on the pareto chart, it can be seen that defects related to weight occupied the top two common defects in the uPVC pipe production

followed by too thick, melted, and crack to complete the top five frequent defects. The common defects for PVC pipe in a production process are melt, crack, and hollow. Among the three defects identified, the majority of the defects were melt and crack (Ginting & Supriadi, 2021).

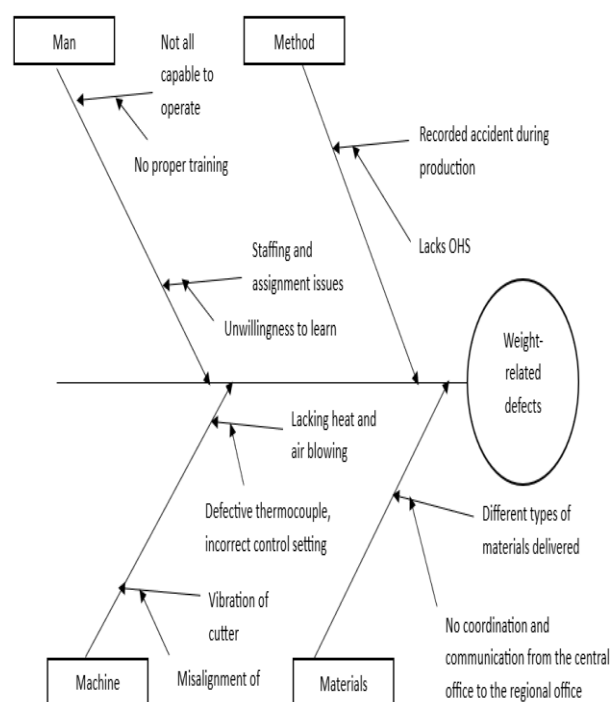
Figure 7. Fishbone diagram of weight-related defects

After finding the common defects, it is helpful to understand their causes using the Ishikawa or fishbone diagram. Figure 7 shows the fishbone diagram of this study for the root-cause-analysis. The diagram explains the causes and were categorized into four major groups namely man, method, machine, and materials. For the man, it contributed to the defects because of not being capable to operate the machines. This happened because there is no proper training for all its personnel. When they were hired, the company did not have a formal training and in fact their minimum qualifications do not match the needed skills and competencies. They just learn how to operate when they were already assigned in the production. Another associated cause is the staffing and assignment issues which becomes a concern because there are other personnel who are not willing to learn or explore and take initiative to get to know the machines and how they are being operated. For the method, one incident happened in the production of the pipes when a certain employee encountered accident due to lack of knowledge on Occupational Health and Safety procedures, so it affected the operation. Another category is about the machine, the extruder part houses the heaters and air blowers for the forming and shaping the pipes. The causes were identified when there is insufficient amount of heat and air-blowing due to defective thermocouples and incorrect control setting. Another

cause is the vibration of the cutter which is caused by the misalignment of its clampers. And lastly, the materials. They have difficulty in mixing the ingredients and provide correct control setting for proper heating and air blowing because the materials or ingredients delivered were not the same as the other batches of materials delivered before. The central office failed to communicate and inform the regional office on the type of ingredients and materials used to also have the correct setting for the operation.
