Robust quantitative X-ray phase diagnostic for carbon composite characterisation in the context of lightning induced risk

Laureen Guitard^{1,2}, Adrien Stolidi¹, Georges Giakoumakis^{1,2}, Rafael Sousa Martins³, Jérôme Primot² & Amelie Jarnac³✉

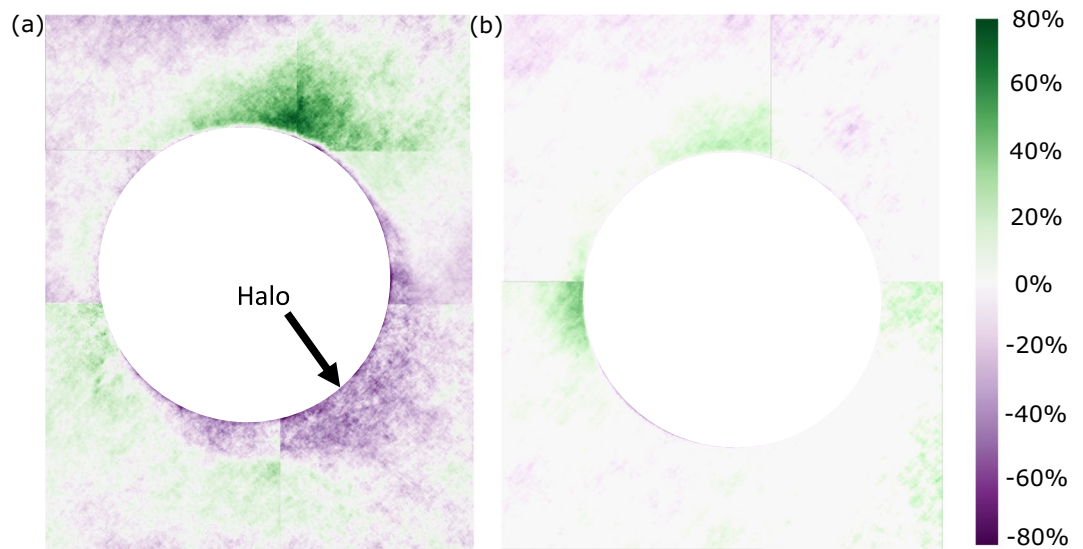
Fig. 5. Color map of relative density variation of (a) the lightning damaged CFRP and (b) the pristine CFRP.

assuming that the proportions of various atomic elements have not changed. These results are reported in Fig. 5a as a color map of the percentage density variations. The color bar is centred in zero, meaning that white areas correspond to regions where the density remains unchanged; purple areas correspond to regions where the density is lower than the initial density; and green areas correspond to regions where the density is higher than the initial density.

To determine the uncertainty of this evaluation, we perform the same procedure on the pristine sample. The resulting relative density variation is shown in Fig. 5b. It can be observed that 99% of the density variation distribution amounts to $\pm 21.9\%$ (3σ). On the other hand, the lightning damaged CFRP exhibits a purple zone at the lower right edge of the hole, indicating a reduction in density of approximately 40%. Two green areas are visible: the first one located at the top right of the hole, depicts an increase in density of 60%; the second one located at the bottom left of the sample, depicts an increase in density of 20% but it may not be entirely reliable as it is too close to the sensitivity of the measurement.

which represents 10.36% of the thickness. This proportion is smaller than the density variation sensitivity. However, the halo represents 46.45% of the thickness which is in good agreement with what is observed in Fig. 5.

In Fig. 6c, a more absorbent area appears at the top edge of the hole over the thickness. The change in contrast does not seem to corroborate the 60% increase of density seen in Fig. 5. It is possible that the assumption of unchanged proportions of atomic elements does not hold here. Indeed, a change in proportion or in elements would contribute to a phase change (see Eq. 1). An increase in phase contrast could arise from a permanent doping of metallic ions from the current injection screw. Indeed, it can be seen in the Fig. 8b that the studied area (fastener 1) has been subjected to sparking phenomena. During this phenomena, the shank of the screw undergoes melting and vaporization and the surrounding materials undergo a strong overpressure³⁹. Moreover, the current was injected through this fastener, meaning that the CFRP emitted electrons and the screw emitted positive metallic ions. The internal pressure and electric field combined together could have favored the diffusion and implementation of metallic ions in the CFRP in the vicinity of the current injection area. Also, notice that the tomography reconstruction is not calibrated. Therefore the gray level dynamic, which is related to the experimental conditions (spectrum, noise) and the reconstruction algorithm (type of filtration), cannot be quantitatively compare to the Fig. 5.

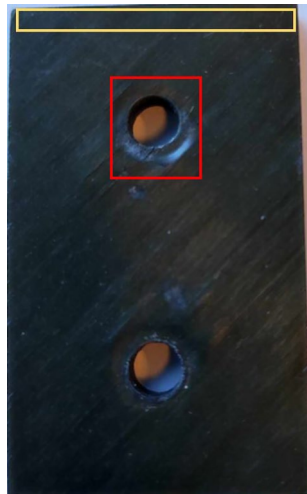
Fig. 9. Photo of the CFRP coupon struck at the ONERA's lightning test facility with the GRIFON generator. The red square corresponds to the area of fastener 1 and is the imaged zone on the CEA's MLSI-XPCI installation. The yellow square corresponds to the undamaged region used to measure the average pristine phase value ϕ_0 .

current can only flow from the fastener 1 to the fastener 2, through the skin. During the current injection, the sample was monitored by a high-speed camera. Figure 8b shows the frame taken at a delay of 33 μ s after the beginning of the current injection. One can see that fastener 1 undergoes sparking. After the lightning test, the CFRP coupon is unmounted and this area on the CEA's MLSI-XPCI bench. A photo of the CFRP coupon after lightning test is shown in Fig. 9.

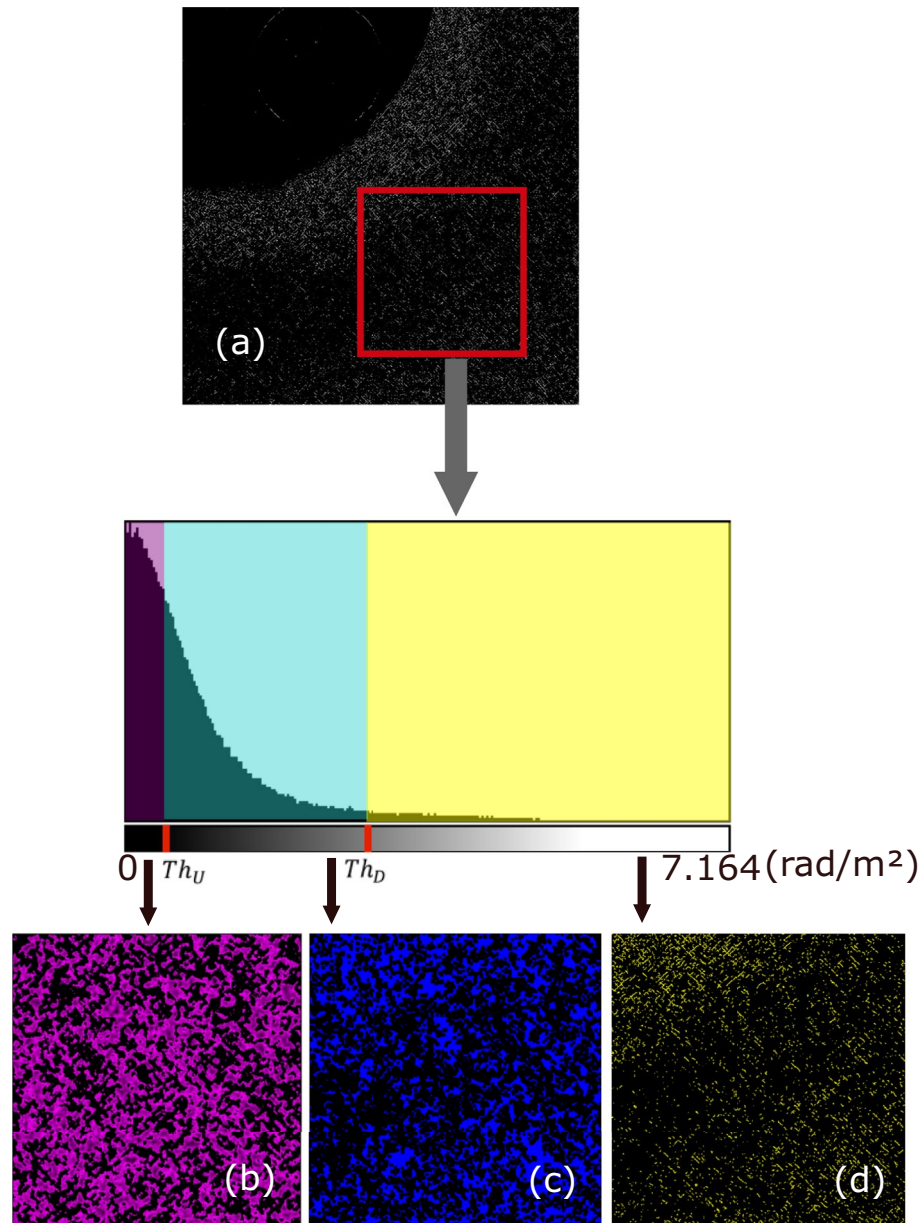
Fig. 10. Construction of the confidence map: from the phase derivative closure map $C(x, y)$ (a) threshold methods are applied to highlight the contribution of noise (b), under sampling (c) and the phase dislocation (d).

Given that the noise contribution is homogeneous and similar across the images (see Fig. 10b), we focus on the contributions arising from dislocation and under sampling errors. These values can be studied on the pristine sample of CFRP and the PMMA sphere. In the Fig. 3, a Region of Interest (ROI) of 195×195 pixels is selected in the PMMA sphere and one of 525×525 in the pristine CFRP. For each of these ROIs, the percentage of dislocation and under sampling alerts is calculated. This means that we observe the number of pixels that light up as an indication of dislocation or under sampling within the ROI, divided by the total number of pixels of the ROI. The PMMA sphere shows 0.08% dislocation alerts and 0.03% under sampling alerts. These values will serve as a reference later on. On the other hand, the CFRP sample, shows about 0.53% dislocations and 0.30% under sampling. Despite being a complex object compared to the PMMA sphere, the number of alerts for the pristine CFRP is low, indicating that the imaging system provides proper analysis conditions and that the homogeneous distribution of fibres in the pristine sample allows for good sampling.

Using the gradient images shown in Fig. 2 and applying the Eq. (5), we can generate the closure phase derivatives image $C(x, y)$ presented as absolute values in Fig. 10a and its associated grey values histogram. As described in³⁷, a confidence map can be built from this histogram. First the threshold Th_d related to the alert ε_d is calculated by using a maximum entropy method⁴². This threshold method consists of assessing the likelihood of an event occurring, in our case phase dislocation and undersampling. Here we find $Th_d = 2.721 \text{ rad/m}^2$. Then each pixel of the image $C(x, y)$ is evaluated and an alert is triggered by coloring pixel in yellow when the pixel value (x_i, y_j) exceeds Th_d . After filtering ε_d , under sampling alerts ε_u and noise alerts ε_n are calculated by evaluating the $C(x, y)$ image with a moving average evaluation window of size of $S_\Omega = (pM_g)/(2S_{pix}) = 2$ pixels in the region of interest defined by the red square in Fig. 11. To differentiate the contribution of ε_u from ε_n , we also use the maximum entropy method. The resulting threshold value is $Th_u = 0.658 \text{ rad/m}^2$. All the ε_d , ε_u and ε_n are displayed in Fig. 10b–d. These images can be merged with the phase image as illustrated in Fig. 3.

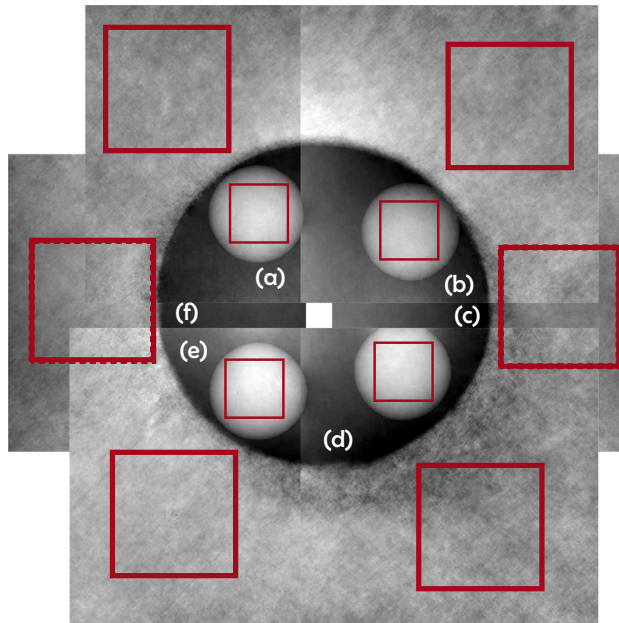
Fig. 11. Region of interest used to apply the Confidence Map. The statistical analysis is performed on ROI of 195×195 pixels for the PMMA standard sphere and on 525×525 pixels for the CFRP. The squares with partially dotted outlines indicate the ROIs taken in the images presented at the rear of the stitching.

To further interpret the phase information, we apply the self-assessment method based on the Confidence Map results on the PMMA and CFRP ROIs defined for each image of the stitching (ROIs are reported on Fig. 11 in “Methods” section). The results are shown in Table 1. The alert values of the PMMA spheres are similar to those in Fig. 3, validating the measurement comparisons. However, the dislocation and under sampling alerts are higher in the damaged CFRP than the pristine sample ($\epsilon_d = 0.53\%$ and $\epsilon_u = 0.30\%$). In particular, the area (d) experiences 5.91% dislocations alerts and 30.36% under sampling alerts. Moreover, the phase image (Fig. 4b bottom right) displays a low contrast area, suggesting presence of an intrinsic defect in the sample. From the

The Fig. 11 displays the regions of interest (ROI) selected for applying the Confidence Map from the Table 1. The high acutance area such as the CFRP edges have been removed to not introduce irrelevant alters values.
