Enhanced impact-resistance of aeronautical quasi-isotropic composite plates through diffused water molecules in epoxy

Furqan Ahmad, Fethi Abbassi, Mazhar Ul-Islam, Frédéric Jacquemin,
Jung-Wuk Hong

Furqan Ahmad, Fethi Abbassi, Mazhar Ul-Islam, Frédéric Jacquemin, Jung-Wuk Hong. Enhanced impact-resistance of aeronautical quasi-isotropic composite plates through diffused water molecules in epoxy. *Scientific Reports*, 2021, 11 (1), pp.1775. 10.1038/s41598-021-81443-w . hal-04737299

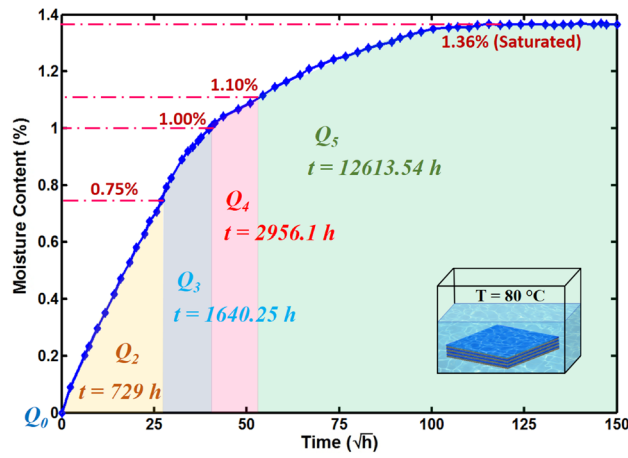
Figure 1. Water absorption behavior of quasi-isotropic composite plate at 80 °C.

For each MC condition, weights of three dry specimens were measured, and then those specimens were immersed in the hot water at 80 °C. All plates were dipped completely into the water, and their average dry and wet weights for different MC conditions are listed in Table 1. From the moisture absorption curve in Fig. 1, it is observed that the dry plate absorbs water quickly and the curve raises linearly up until it absorbed almost 65% of its final saturated MC level. After that, the water absorption rate becomes very slow and the curve converges to the point of saturation. The composite plate absorbs the water molecules of 0.75% of its weight in the time period of 729 h and then took a long time of 1640.25 h to reach MC level of 1.0%. The 1.1% MC level, which is the fourth condition in this study, was achieved in the time period of 2956.1 h. To achieve a fully saturated level which is 1.36%, we need the immersion time of 12,613.54 h. To analyze the hygroscopic effects on the strength of the interfacial bond between the reinforced carbon fibers and epoxy matrix SEM, fractographies were performed for the fully dry and fully saturated plates as shown in Fig. 2. For the completely dry composite plate, a tight interfacial bonding between the carbon fiber and epoxy is seen clearly in Fig. 2a. When composite plates are immersed in the hot water, the carbon fibers do not absorb the water, and the moisture expansion coefficient is almost zero while the epoxy matrix has a high moisture expansion coefficient and absorbs almost all of the water molecules. Due to absorbing water molecules, the epoxy matrix swelled up and caused interfacial debonding with the carbon fibers as shown in Fig. 2b.

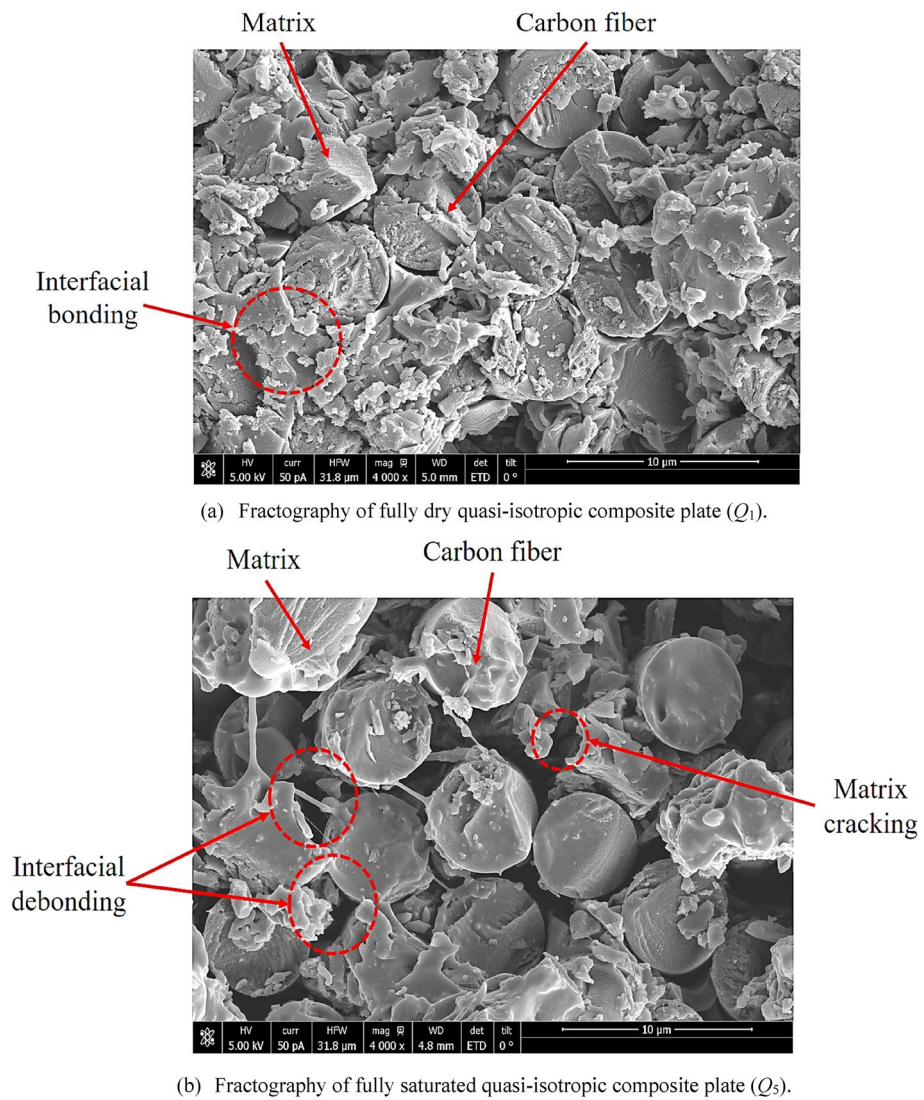
Figure 2. SEM fractographies for (a) fully dry and (b) fully saturation quasi-isotropic composite plates.

Based on the low-velocity impact test results, it can be concluded that the elastic deformation capacity of the composite plates was improved by absorbing the MC. From the SEM fractography (Fig. 2) of fully dry (Q_1) and saturated (Q_5) composite plates, it was observed that absorbed MC had minimal effects on the carbon fibers and

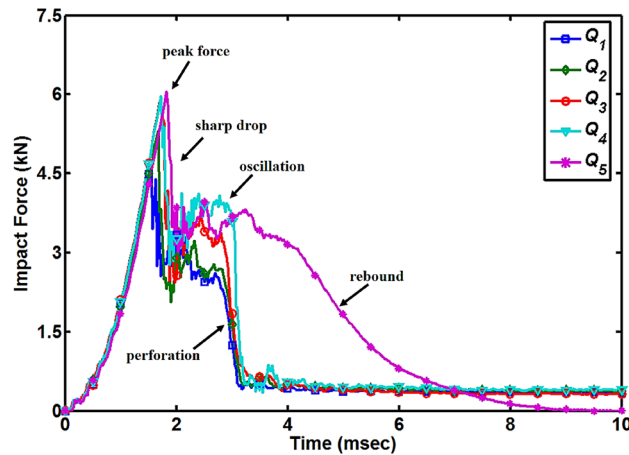
Figure 3. Impact force versus time diagram for all quasi-isotropic composite plates.

When the hemispherical shaped impactor contacts on the surfaces of the composite plates, the responses of those composite plates were obtained in form of voltage versus time graphs using a load cell, and later these data were converted to force versus time graphs. Complete depiction of the contact between hemispherical shape impactor and composite plates can be studied from the force versus time graph which gives the details of incipient damage, layer-by-layer damage growth, and overall changes in the impact-resistance of the composite plates. Force versus time graphs for all the quasi-isotropic composite plates is shown in Fig. 3. During the experimental tests, as the impactor hit the top layer of 0° of the composite plates, the impact damages in form of matrix cracking at a micro-level and delamination between the adjacent layers started and these damages can be observed as an oscillation at the beginning of the force curves. These oscillations in the force curves are referred to as Hertzian failure of the composite materials. All the curves moved toward their peak force values with the almost same slope, which indicates the out-of-plane stiffness of the quasi-isotropic composite plates does not affect. Initially, the majority of the impact load was carried by the carbon fibers which were not affected by the absorbed MC. All the curves reached their peak force values in a linear manner without any oscillations in a short period of time. After the peak force point, a sharp drop was observed which is the indication of rapid extension of damages. Through the thickness of the plates, damages occurred in the form of matrix cracking and fiber breakage which appears as large scale oscillations in the force curves. For the first four cases (Q_1 to Q_4), after the large scale oscillations, again a sharp drop happened which is the indication that all carbon fiber dominated layers of composite plates are broken and impactor is perforated through the plates. Small scale oscillations happened after the perforation due to the friction between the perforated plates and impactor surface during the downward movement of the impactor. For the fully saturated composite plate (Q_5), after the large scale oscillations, a smooth drop of the curve was observed which is the indication that the impactor is rebounding back and no damage occurred in this rebound portion. Impact event characteristics changed because of the absorbed MC from the supercritical impact event for the Q_1 composite plate to the critical impact event for the Q_5 composite plate^{15,16}. Q_5 composite plate got the highest peak force value of 6.054 kN and Q_1 composite plate showed the lowest peak force value of 4.651 kN which means due to absorbed MC the impact-resistance of the quasi-isotropic composite plates increased. The time corresponding to the peak force value also increased with the increase of the percentage of the absorbed MC, implying that the first significant damage of quasi-isotropic or occurrence of incipient damage is delayed by 0.275 ms for Q_5 composite plate from the Q_1 composite plate as shown in Fig. 3. The peak force values and their corresponding times for all specimens are shown in Table 2.

As shown in Fig. 3, time to reach the peak force point is a delay with the increase of MC and the occurrence of the first significant damage or a sharp drop in the time-force curves also delayed. This delay in the first significant damage can also be observed in Fig. 6 which shows that damages in Q_5 composite plate started at the larger displacement of the impactor corresponding to higher strain level compare to Q_1 composite plate. This delay in the occurrence of the damages shows that the ductility of matrix resin improved due to the presence of MC. The improved ductility would benefit the laminate by hindering the initiation of inter-laminar cracks and matrix cracking but debonding and fiber breakage will not be delayed. Improved ductility of the matrix resin, increased the strain to first significant failure and hygroscopic conditioned quasi-isotropic composite plates preserved their structural integrity up to a large displacement of the impactor. The ductility of matrix resin increase with the increase of the percentage of MC.

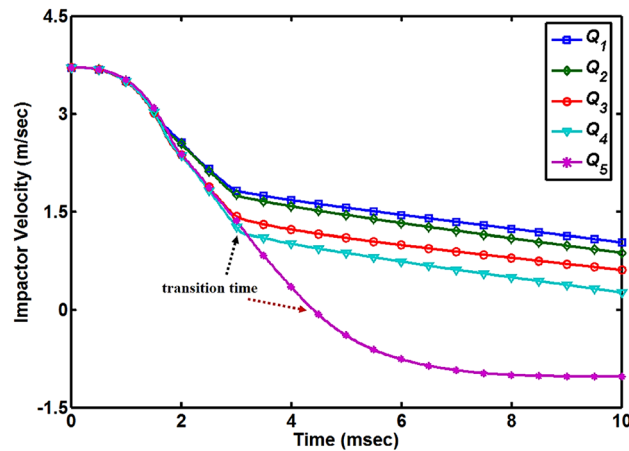
Figure 4. Impactor velocity versus time diagram for all quasi-isotropic composite plates.

where v_t and d_t is the impactor velocity and displacement at time t , v_i and d_i is the initial velocity and displacement of the impactor just before contact with the top surface of the composite plate, F_i is the recorded force of the impact and m_i is the impactor load. The time-velocity curves for all the quasi-isotropic composite plates are shown in Fig. 4. For the first four cases (Q_1 to Q_4), the impactor velocity curves dropped quickly from their initial value of 3.71 m/s to the time at the second sharp drop in the time-force curves occurred which is corresponding to the failure of the composite layers and impactor is perforated through all layers. The time corresponding to this point is called transition time (showing with dotted black arrow) and after this point, the drop in the curves is small and linear which is the indication that the length of the impactor is passing slowly through the thickness of the composite plates. For the Q_5 composite plate, the time-velocity curve dropped quickly from the initial velocity level and become zero at the transition time (showing with dotted red arrow) and after this point, the velocity of impactor become negative which mean the impactor started to rebound. The rebound of the impactor cannot be observed in the time-force curve so that's why it is important to draw the impactor velocity graph for a better understanding of the impact behavior of the quasi-isotropic composite plates. With the increase in the percentage of MC, the transition time of composite plates increased. Time-impactor displacement curves for all five MC conditions are shown in Fig. 5. During the impact tests, the impactor kept moving without any barrier on it and displacement curves for the first four (Q_1 to Q_4) cases increased. Q_1 composite plate shows less resistance to the impactor and got the maximum displacement value of 18.68 mm at a time of 10 ms and at the same time Q_4 composite plate shows less displacement level of 13.29 mm. Impactor does not perforate through the Q_5 composite plate and when at the point of impact maximum deflection of the plate occurred, the impactor achieved its maximum displacement of 9.47 mm and after the transition time impactor started to rebound back to zero displacement position (original level) where it will be completely detached from the top layer of 0° . The displacement versus force curves of all the five MC conditioned specimens are shown in Fig. 6. This rebound back of the hemispherical head impactor can also be observed in Fig. 6 where displacement versus force curve started to fold with decreasing displacement of the impactor. As impactor perforated through the first four quasi-isotropic composite plates (Q_1 to Q_4), there is no fold of displacement versus force curves observed for these specimens. Displacement of the impactor decrease with the increase of MC and impactor rebound back for Q_5 specimens indicated that the impact-resistance of quasi-isotropic composite plates improved under hygroscopic effect.

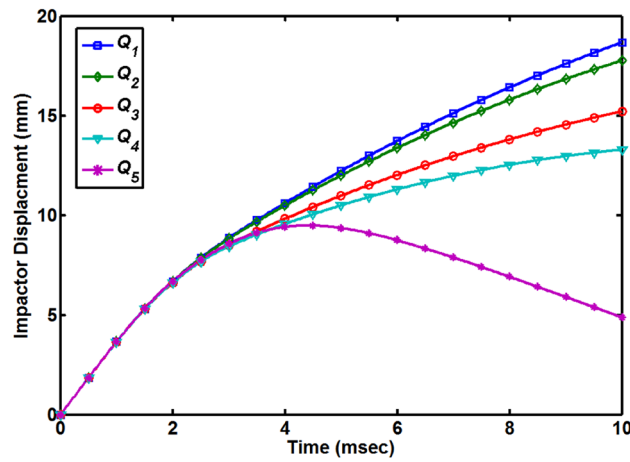
Figure 5. Impactor displacement versus time diagram for all quasi-isotropic composite plates.

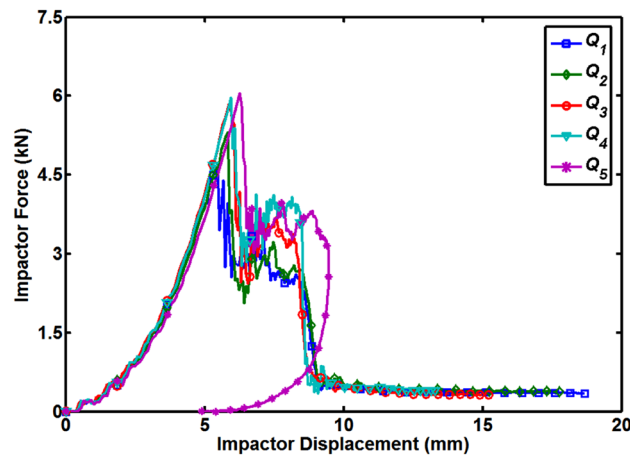
Figure 6. Impact force versus displacement diagram for all quasi-isotropic composite plates.

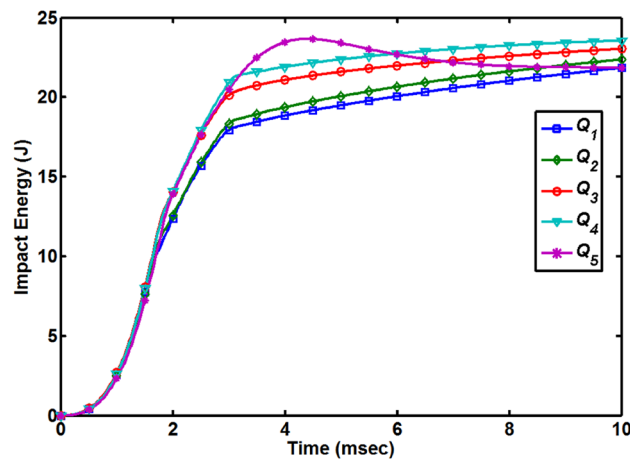
Figure 7. Absorbed energy versus time diagram for all quasi-isotropic composite plates.

To analysis the hygroscopic effect on the impact-resistance of the quasi-isotropic composite plates, impact tests were performed under the same level of impact energy of 23.67 J. Energy versus time graphs for all the quasi-isotropic composite plates are shown in Fig. 7. During the impact tests, energy absorbed by the quasi-isotropic composite plates from the energy applied by the impactor was calculated as

where E_i is the initial or applied energy and E_a is the absorbed energy. In Fig. 7, energy curves can be categorized into two cases: impactor perforated through the plates (for first four cases Q_1 to Q_4) and impactor penetrated the plate (for Q_5 composite plate) and rebound back. Initially, the rate to absorb the impact energy was very low for all the composite plates which was attributed to the initiation of damage in form of dent on the top surface and crack along the thickness direction at the point of impact. After that between the time period of 1 to 2 ms, the composite plates absorbed the impact energy during the deflection of the composite plates and the slopes of all energy curves were increased quickly and internal damages were produced in composite plates. Energy curves for the first four cases (Q_1 to Q_4) rise with a large slope progressively until the maximum deflection of the composite plates reached and internal damages started in the plates. When the impactor perforated through these composite plates, maximum energy was absorbed by the plates after that the energy curves appeared to further increase because the later surface of the impactor still has contact with the circular edges of the perforated plates. For the Q_5 composite plate, after reaching the peak point the energy curve starts decreasing progressively which is an indication that impactor has started the rebound. It is reasonable to state that when the impactor and plate detached completely, any further absorption of the energy did not occur.

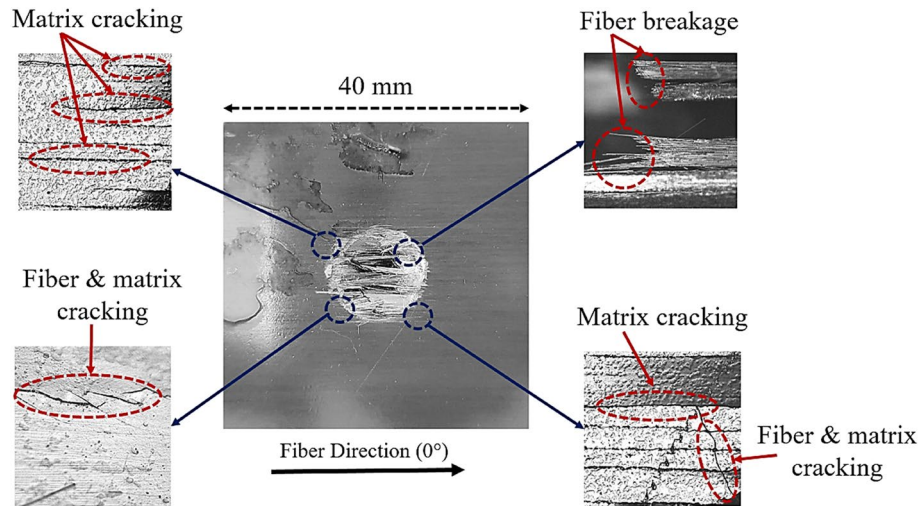
Figure 8. Damages on the top face of fully dry composite plate (Q_1).

Impact damage analysis. Whenever an object falls on the composite structures, a complicated damage mechanism consists of different failure modes are created. Matrix cracking, fiber, and matrix breakage, fiber and matrix interfacial debonding, inter-laminar cracking, and delamination are the major damage modes that will occur under impact loading and these modes also interact with each other^{17,18}. Damage in the form of matrix failure initiates in the composite materials when the applied impact energy surpassed the threshold level. Compared to the matrix, more impact energy is required to fail the fibers in the composite materials. It is reasonable to say that strength and impact resistance of the composite materials mainly depend more on matrix strength than the fiber strength. For all five cases (Q_1 to Q_5), when impactor dropped on the top face of the composite plates, fiber breakage, fiber cracking, and matrix cracking were observed as shown in Fig. 8 for Q_1 composite plate. At the point of impact, fibers were broken and the matrix was failed due to indentation effects which cause local high stresses. The top and bottom faces of the Q_1 composite plate are shown in Fig. 9i. As the impactor perforated through this plate, circular shape damage was observed on the front face and underneath the impact point between the last two layers delamination was occurred. Impactor did not perforate through the Q_5 composite plate but create a large dent on the top face as shown in Fig. 9ii. Different damage modes such as matrix and fiber crushing, matrix cracking, and fibers breakage took place underneath of impact point on the top face, and delamination was observed on the back face. From Fig. 9 it can be observed that more damages occurred in the Q_1 composite plate compare to the Q_5 composite plate means impact-resistance of quasi-isotropic composite plates improved with the presence of absorbed MC.

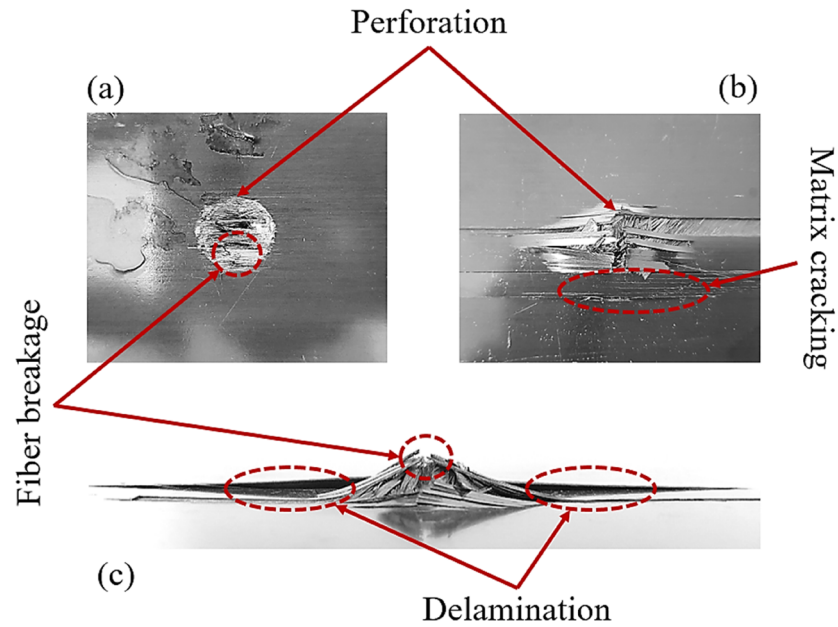
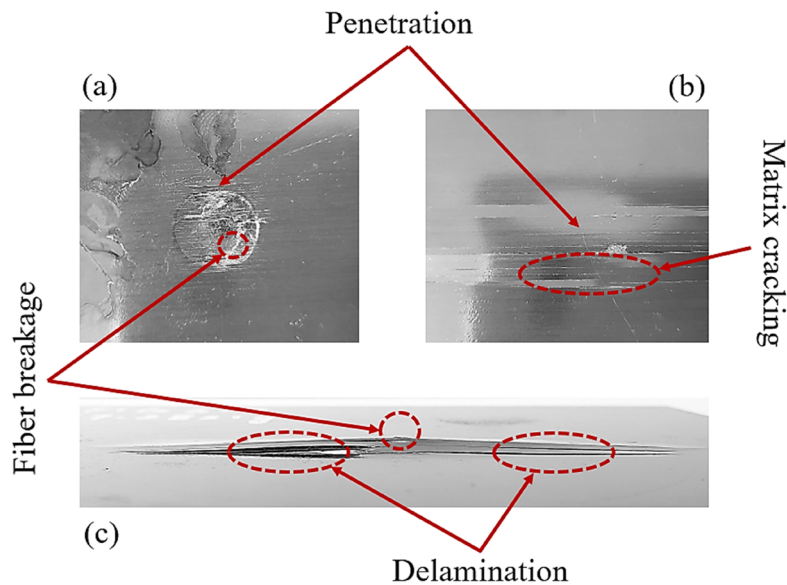
i) Damages in the fully dry (Q_1) composite plate (a) top view, (b) bottom view and (c) side view.

ii) Damages in the fully saturated (Q_5) composite plate (a) top view, (b) bottom view and (c) side view

Figure 9. Different views of damages in (i) fully dry (Q_1) and (ii) fully saturated (Q_5) composite plates.

was observed due to increase ductility of composite plates and damages in fully saturated (Q_5) composite plate occurred at the larger displacement of the impactor compare to fully dry (Q_1) composite plate. The overall size of damages on the top and bottom faces decreases with an increase of the percentage of MC. More damage was observed for the fully dry composite plate (Q_1) compared to hygroscopic conditioned composite plates (Q_2 to Q_5). From the current study, it is reasonable to say that the presence of the MC improved the ductility of quasi-isotropic composite plates and eventually enhanced the impact-resistance of the quasi-isotropic composite plates under low-velocity impact loading.

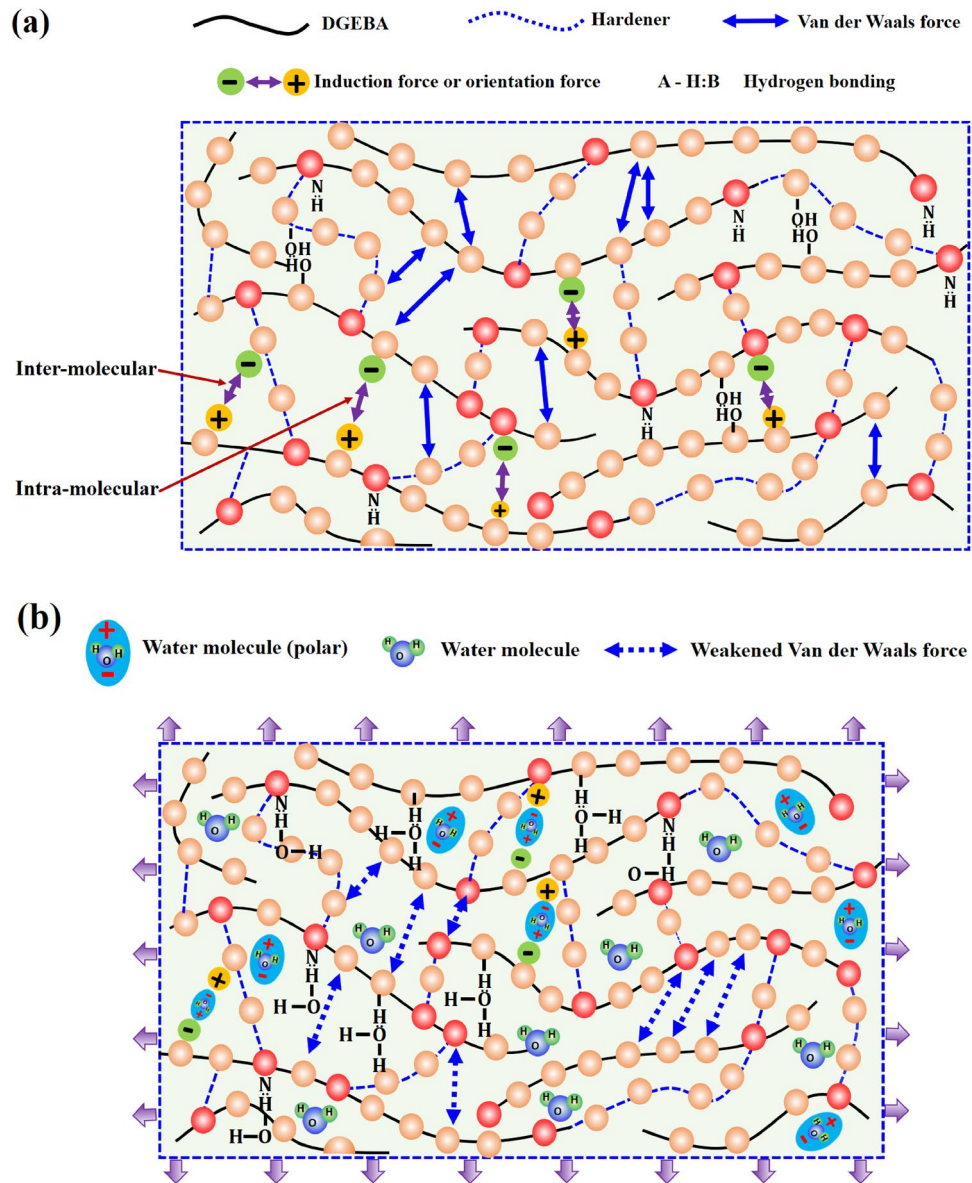
Figure 11. Schematic diagram of the (a) Van der Waals force, induction force or orientation force, and hydrogen bonding of epoxy molecules before absorbing the moisture content and (b) interaction between the moisture content and epoxy, weakened Van der Waals force, and disruption of hydrogen bonding of epoxy molecules after absorbing moisture.

had some effect on the interfacial bond between fiber and matrix. Therefore, it can be postulated that absorbed MC affects the matrix resin and improve the elastic deformation capacity of composite plates^{5,6}. Compare to the water molecules, the molecules of the cured epoxy are large in size. That's why water molecules can diffuse into the epoxy resin network easily and reside in the vacancies between the chains of the epoxy molecules and cause an increase in the overall thickness of the composite plate and expansion of its volume. The covalent bond force between the small molecules are normally greater in magnitude (one to two times) compare to the Van der Waals force. Polymers molecules have long structural chains and greater in number which characterized them huge molar mass structures. The inter-molecular force (Van der Waals force) of the long structural chain of the polymer molecule is comparatively high than the covalent bond force. Figure 10 shows the formation of the crosslinked polymers from reactants (epoxy and amine hardener). During the curing cycle, each amine group of the hardener molecule (Diethylenetriamine (DETA) or Meta Phenylene Diamine (MPDA) hardener) have two active atoms of the hydrogen which react with the epoxy (Diglycidyl Ether of Bisphenol A (DGEBA) molecule) molecule and form the long-chain structure of the crosslinked polymers and inter-molecular force became stronger than the covalent bond force^{5,6}. This strong inter-molecular force leads to the brittle behavior of the fully dried composite material under the impact loading. The inter-molecular force in the long structure of the polymer molecule is classified into two parts, Van der Waals force, and hydrogen bonding. Van der Waals force is further divided into three parts such as orientation force, induction force, and dispersion forces as shown in Fig. 11a. There are two aspects by which the intermolecular force of polymer molecules can be weakened by the interaction between the epoxy resin and water molecules (Fig. 11b). Firstly, the Van der Waals force between the polymer molecules is effective up to a certain distance and beyond this distance starts to become weaker. As large-sized water molecules diffused in the long structure of the polymer molecules, the distance between the polymer molecules increased and the Van der Waals force becomes weak. Induction and orientation forces are mainly depending upon the polar groups of the polymer molecules and water molecules are also polar molecules as shown in Fig. 11b. So, the water molecules make coupling with the polymer molecules and weaken the induction and orientation forces. Secondly, the amine and hydroxyl groups of the epoxy resin are ready to make the hydrogen bonding. The diffused water molecules can also create hydrogen bonding with epoxy molecular chains and reduced the number of hydrogen bonding of the epoxy resin. Due to the expansion of the volume of the epoxy resin, some hydrogen bonds may also destroy. Therefore, hydrogen bonding became weak due to the presence of the absorbed MC. It can be concluded that overall inter-molecular attractive forces of the long-chain epoxy resin were became weakened due to the presence of the absorbed MCs by hindering the Van der Waals forces and disrupting the hydrogen bonding of the epoxy resin. The behavior of the hygroscopic composite plates changed from brittle to ductile because of promotion in the movement of the various epoxy resin molecules and other molecules against each other.

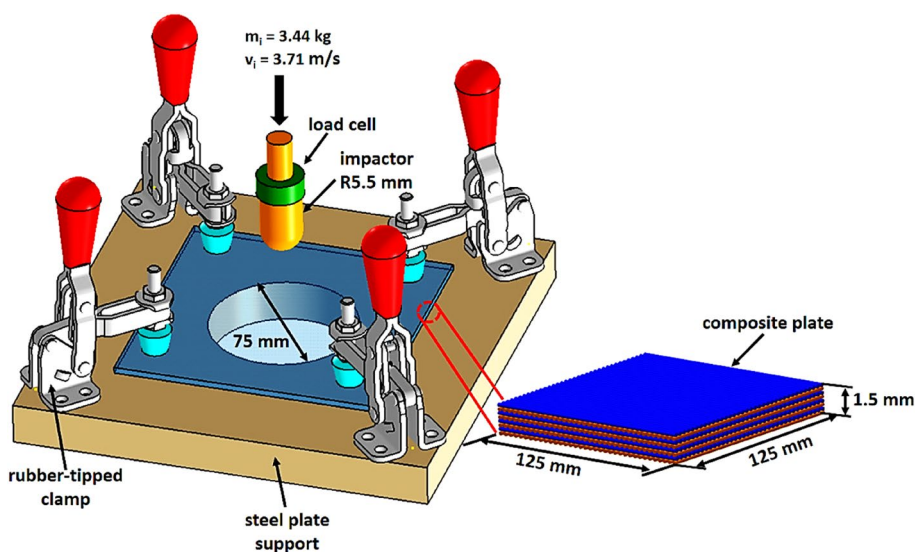
Figure 12. Schematic diagram low-velocity impact test for quasi-isotropic composite plates.

Vertical impact testing machine was used to perform the low-velocity impact tests on dry and hygroscopic conditioned quasi-isotropic composite plates. Schematic diagram of the complete low-velocity impact testing set up is shown in Fig. 12. The total mass of impactor (m_i) including all add-on weights and load cell was 3.44 kg and 0.7 m height of impactor (h_i) was selected corresponding to initial impact velocity (v_i) of 3.71 m/s and provide the impact energy of 23.67 J. To analyze the hygroscopic effect, all the composite plates were tested under constant boundary conditions. Composite plates were put on the steel plate support that has a circular cut of 75 mm diameter at the center to allow perforation of impactor through the thickness of plates without any interference. To prevent in and out of the plane movement of the composite plate, the plates were clamped at four

corners by the rubber-tipped clamps those applying the light clamping pressure. All this arrangement simulates the simply-supported boundary condition. For each hygroscopic condition, three impact tests were performed to avoid the experimental error and after impact test, composite plates were removed from the fixture with care for the post-impact damage analyses.
