Experimental investigation on the fire behaviour of wooden facades

ABSTRACT

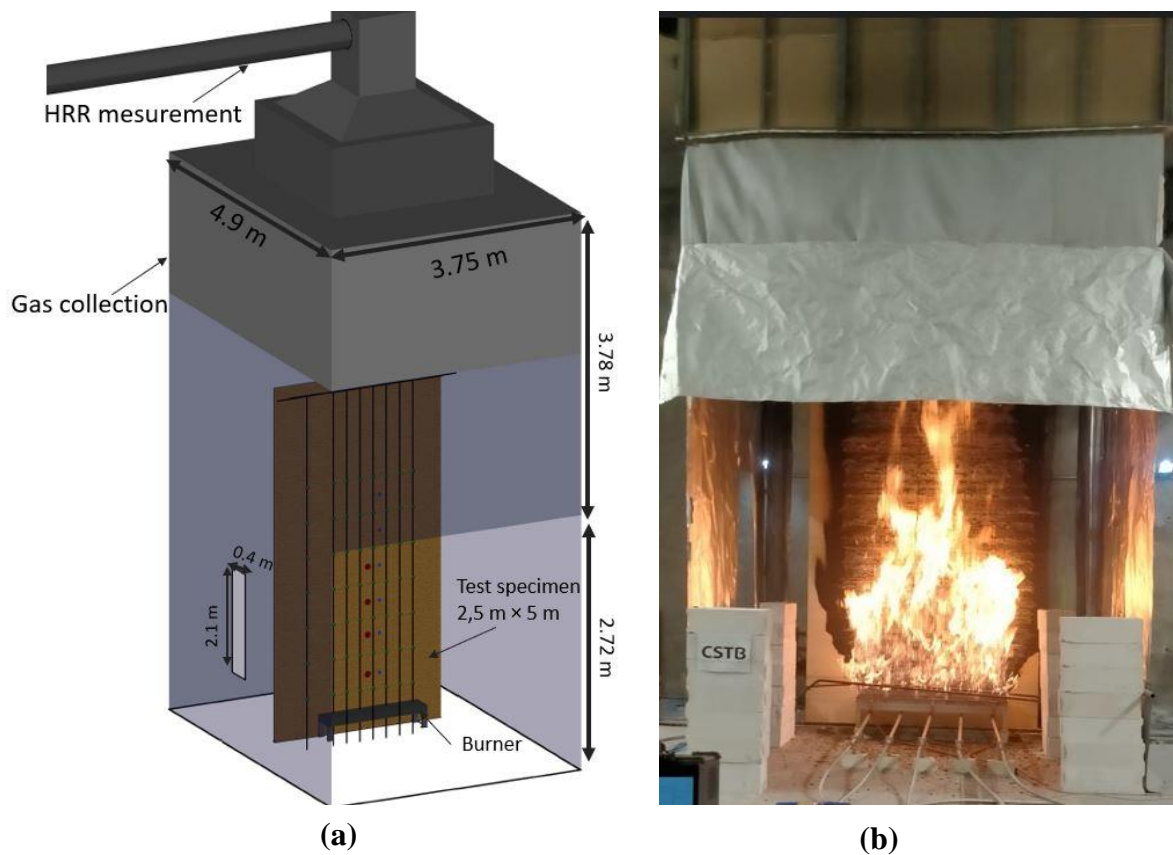
Figure 1 Experimental set-up (a) sketch of test bench (b) picture of a wooden facade test

The tests were carried out on a non-combustible and combustible wall measuring 2.5 m wide, 5 m high and 0.04 m thick. The walls were placed under a calorimetric hood with a section of 4.9 m × 3.75 m. Fiberglass curtains with an aluminized face were added to the test bench in order to improve the collection of combustion effluents by the calorimetric hood. An opening of 0.4 m × 2.1 m was created on the left side to visualize the lateral profile flame. Spruce wood with a density of 440 kg/m³ and nominal moisture content of 11% was used as testing material in the case of combustible façade while in the case of a non-combustible façade, the test was carried out on calcium silicate with a density of 870 kg/m³. There is no cavity between the wooden wall and the calcium silicate in the case of combustible façade test.

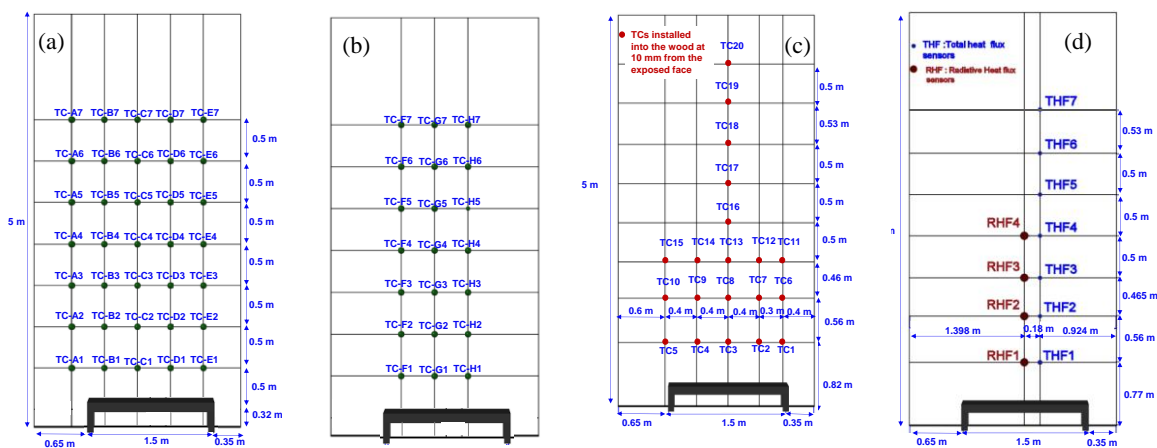
Figure 2 Positions of measurement sensors (a) and (b) thermocouples to measure gas temperatures (b) thermocouples to measure in-depth temperatures and (c) heat flux sensors

To measure the gas temperature near the wall, 56 K-type thermocouples of size 1.5 mm were used. A series of 35 TCs was installed 15 cm from the exposed face and another of 21 TCs was installed 40 cm

from the exposed face. Figure 2 shows a detailed overview of the positions of all thermocouples. In the case of a combustible facade, K-type thermocouples of size 0.6 mm were installed at 10 mm from the exposed face to evaluate the temperature development into the wood. The holes for thermocouples were drilled perpendicular to the isotherms. Figure 2 shows the positions of these sensors. The Total Heat Flux (THF) perceived by the walls was measured using water-cooled heat flux gauges (Hukseflux SBG01) with an external diameter of 25 mm, 10 mm sensor diameter and a measurement range from 0 to 200 kW/m². These heat flux sensors work on both Gardon and Schmidt–Boelter technology. Radiative Heat Flux (RHF) was measured with CAPTEC sensors that were placed in an enclosure with a Zinc Selenide (ZnSe) window to prevent measuring the convective heat flux. A slight breeze of air was blown on this window to prevent soot or other combustion products from settling on it. These sensors were calibrated with the ZnSe window to determine their sensitivity. Figure 2 shows the positions of the total heat flux sensors and those of the radiative heat flux sensors. All the sensors were set flush with the surface of the wall.

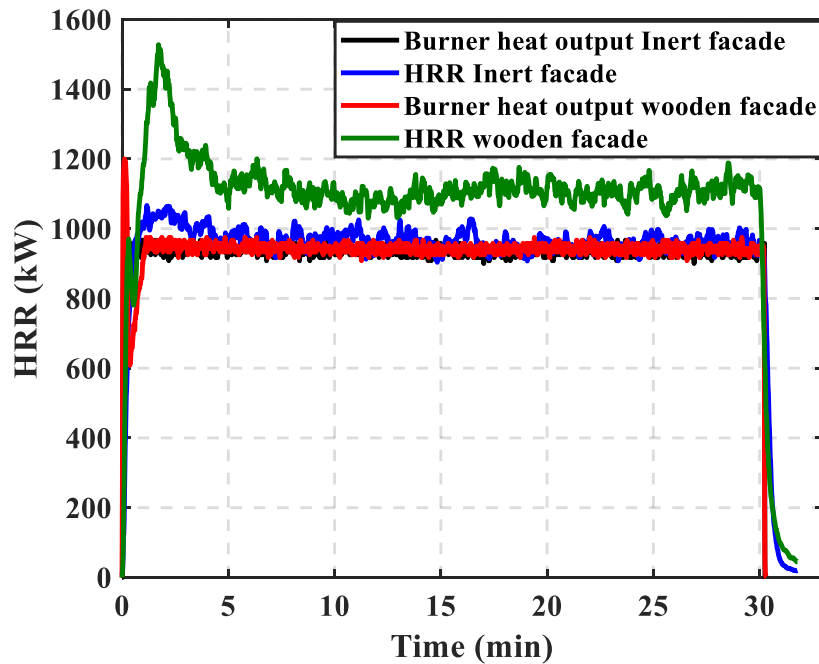
Figure 3 Temporal evolution of heat release rate

Figure 3 shows the temporal evolution of heat release rate estimated using the oxygen-depletion method and heat output of the burner in the case of inert facade and wooden facade test. The both facades were exposed to a heat output burner of 950 kW maintained constant throughout the duration of the test. The heat release rate in the case of inert facade is identical to the imposed heat output. This comparison makes it possible to validate the accuracy of the measurement method based on analysis of gaseous combustion products (collected via the exhaust hood). In the case of the wooden facade, a typical HRR curve of thermally thick charring materials was obtained [7]. A rapid increase in HRR was observed immediately after ignition. Indeed, a peak HRR value of 1530 kW is reached at about 2 min from the beginning of the test which is attributed to the ignition of volatile pyrolysis gases. Subsequently, the HRR decreased to a value of 1080 kW at around 13 min and then increased again slightly (by 35 kW) until the end of the test. This effect is related to the formation of the insulating char layer which limit the heat transfer to the in-depth virgin wood, thus wood pyrolysis decreases. The

comparison of the HRR curves obtained in the two tests clearly shows a significant contribution of the wooden facade which reaches a maximum value of around 580 kW.

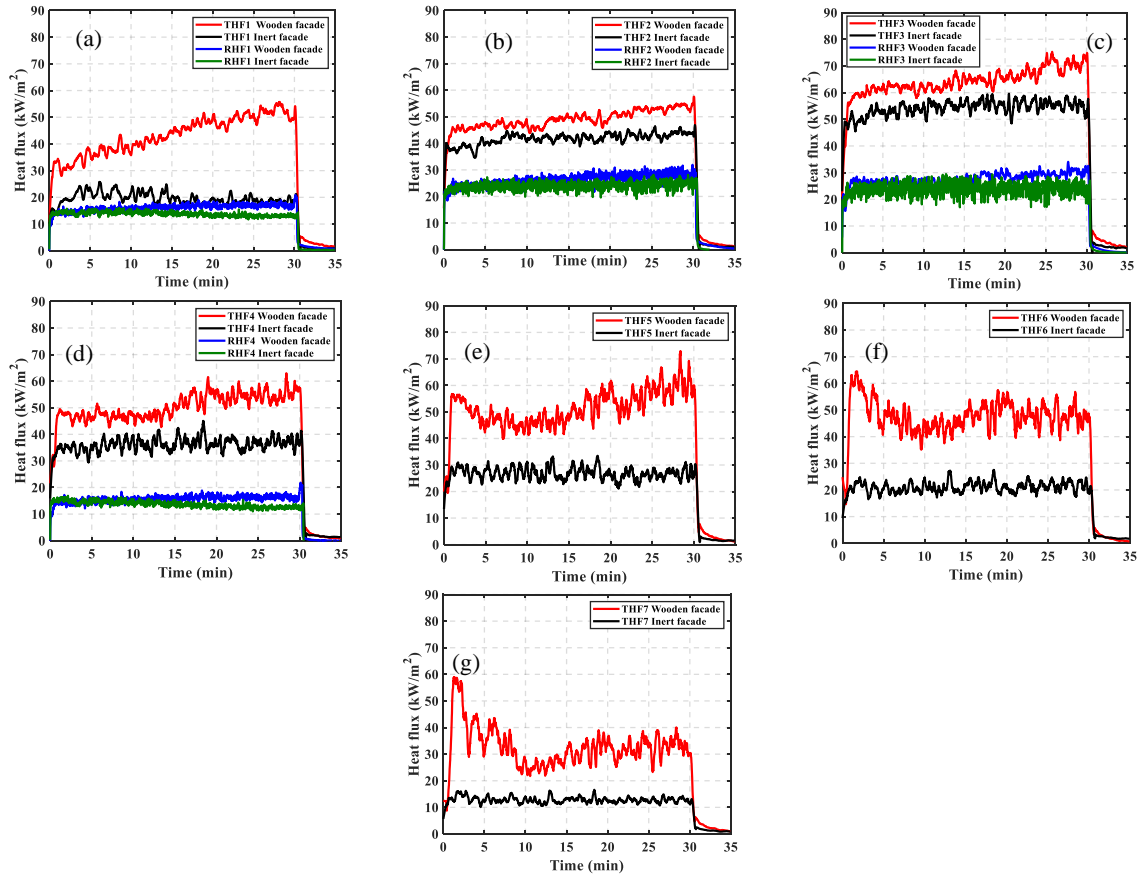
Figure 4 Temporal evolution of total and radiative heat flux (a) 0,5 m (b) 1 m (c) 1.5 m (d) 2 m (e) 2.5 m (f) 3 m (g) 3.5 m

Figure 4 illustrates the temporal evolution of the total heat and radiative heat fluxes received in the case of the inert facade and the wooden facade. The curves of total heat flux were filtered (smoothed) to minimize the effect of the signal noise. In the wooden facade, it can be noted that the curves obtained by FT5, FT6 and FT7 sensors, located respectively at 2.29 m, 2.79 m, 3.23 m from the bottom panel, show a trend similar to that of HRR (Figure 3). The three curves indicate a heat flux peak at 2 min followed by a drop and then a slight increase from around 13 min as observed in the HRR curve. In addition, the heat flux measured with the wooden panel is almost twice the heat flux with the inert panel. It is explained by the fact that the flame with the wooden panel is higher than with the inert panel, thus the heat flux in the upper part of the panel is more affected by the fact the panel burns or not. On the contrary, in the bottom part of the panel, for sensors from FT1 to FT4, the influence is not so large because the flame is present whether the panel is flammable or not, and its thickness and temperature are not very modified.

Heat fluxmeters in this zone are the least affected by any fire growth further away from the burner as mentioned by Zeinali et al. 2018 [8]. A continuous increase of the measured heat flux during the test is observed which can be explained by the deposit of soot, tar, and dust on the sensitive area of the sensors (we notice that total heat fluxmeter are not protected against deposits on their surface). This can cause a significant variation of the calibration constants and consequently of the measured heat flux. Bundy et al 2007 [9] reported that that the soot coating on the sensors could add an additional uncertainty of $\pm 10\%$ due to variations in surface emissivity, and soot agglomerates shadowing the surface of the sensors.

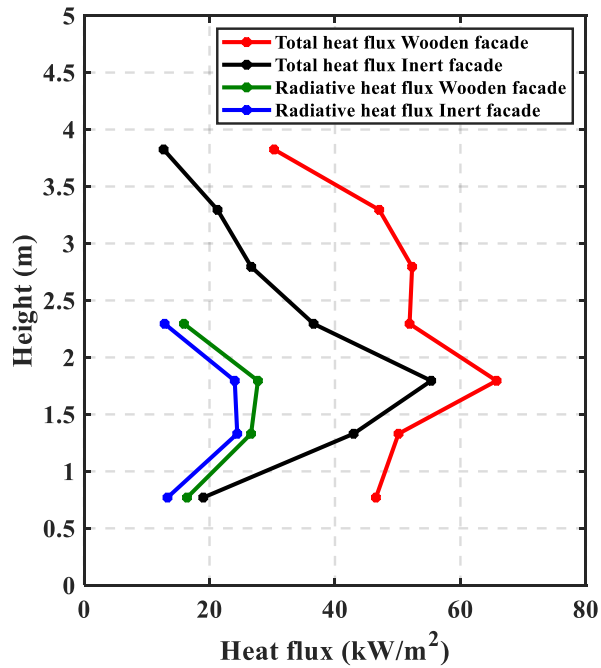
Figure 5 vertical profiles of total and radiative heat flux

Figure 5 shows the evolution of total and radiative fluxes as a function of wall height. The values shown are averages over the last 15 minutes of the test. All curves show the same evolution. The heat flux increases up to a maximum value and then decreases linearly as a function of wall height. This trend is in agreement with that found in the literature, where the evolution of heat flux as a function of a vertical wall height is divided into three zones corresponding to the three flame regions (continuous flame, intermittent flame, and buoyant plume) [2].

It is clear that in the figure the total fluxes are much higher than the radiative fluxes for both inert and wooden facade. Maximum total flux values reached are 55 kW and 65 kW respectively for the inert

facade and the wooden facade. These values are recorded by the THF 3 located at 1.79 m from the bottom wall. Similarly, the maximum radiative fluxes were measured at the same position by RHF 3, the values reach 24 kW and 26 kW respectively for the inert facade and the wooden facade. These two values are quite similar because the flame in both cases is similar, just a bit more sooty and therefore emissive with the wooden panel.

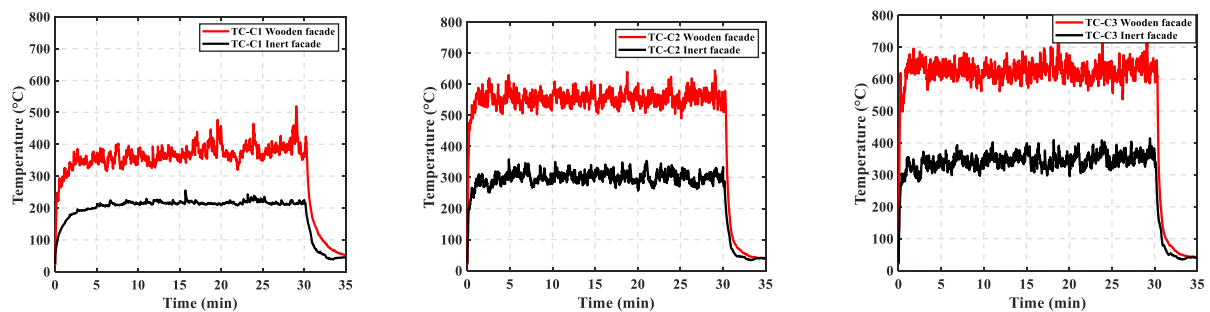
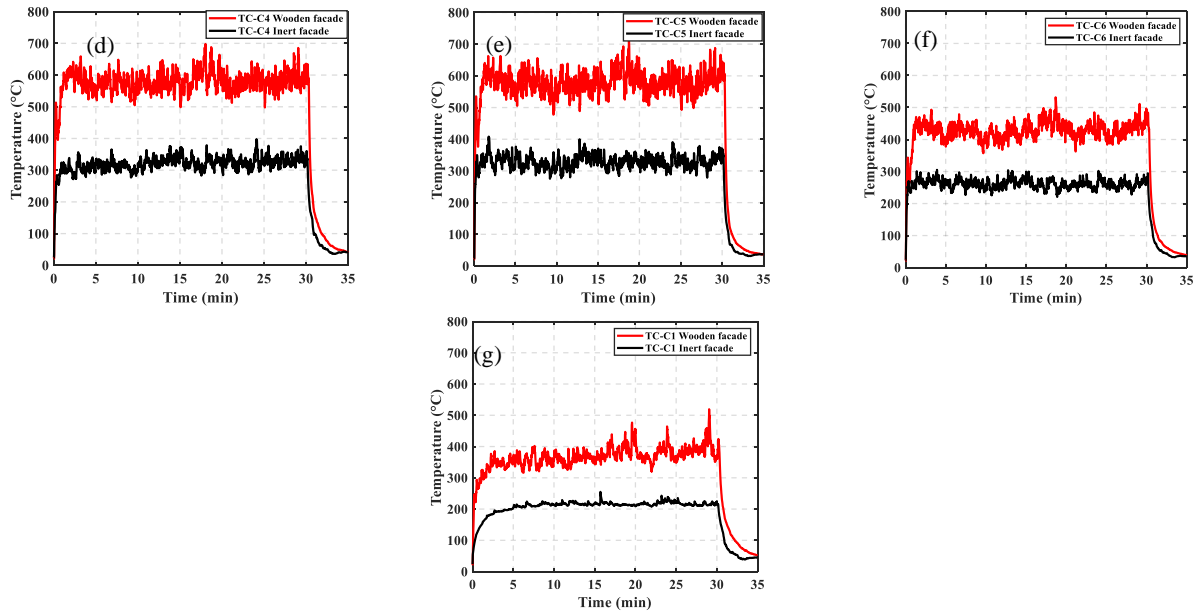
Figure 6 Gas temperatures along the centreline of façade (a) 0,5 m (b) 1 m (c) 1.5 m (d) 2 m (e) 2.5 m (f) 3 m (g) 3.5 m

Figure 6 depicts the temporal evolution of gas temperatures recorded by a series of thermocouples along the centerline of the facade (TC-C tree), located 15 cm from the exposed face. Immediately after the start of test, temperatures increase rapidly and reach their maximum values. These temperatures remain almost stable throughout the duration of the test. Because the thermocouples have a large diameter and were not corrected from radiative losses, the measured temperatures are very significantly underestimated compared to the actual gas/flame temperature. The temperatures measured with wooden facade are much higher than those measured on the inert façade because the wood panel is much hotter than the inert panel and thus the thermocouples are also subjected to a higher radiative flux coming from the panel surface. The difference reaches 300 °C at 1.5 m (TC-C 3) in continuous flame region and around 170 °C at 3.5 m.

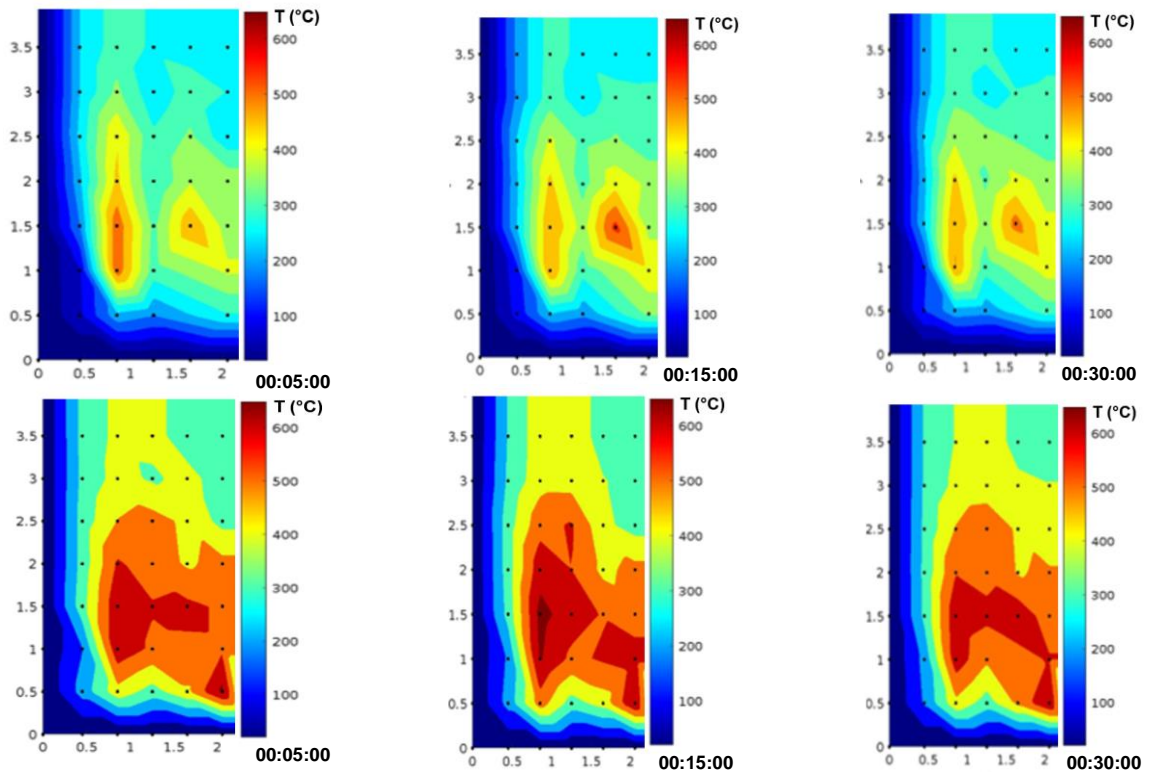
Figure 7 Maps of gas temperatures at different time after ignition , time is given as (hh:mm:ss).

To better visualise the temperature variations in the facade, temperature distributions were obtained through bilinear interpolation from the thermocouples measurements. Figure 7 shows the temperature distribution maps at different times of test (5 min, 15 min and 30 min) for the wooden and the inert facade. As previously mentioned, the maps obtained show that the temperature field remains constant over time. The asymmetry observed is mainly due to the fact that the burner is offset to the right of the facade for technical reasons. We note that the highest temperatures are measured at the lower part of the facade (between 0.5 m and 2.5 m). The temperatures reached values of 675 °C and 520 °C respectively for the wooden and the inert facade and then decrease in the vertical direction. Indeed, the temperatures obtained with the wooden facade in the upper part of the wall (from 3 m) are around 400 °C and less than 300 °C with the inert facade.

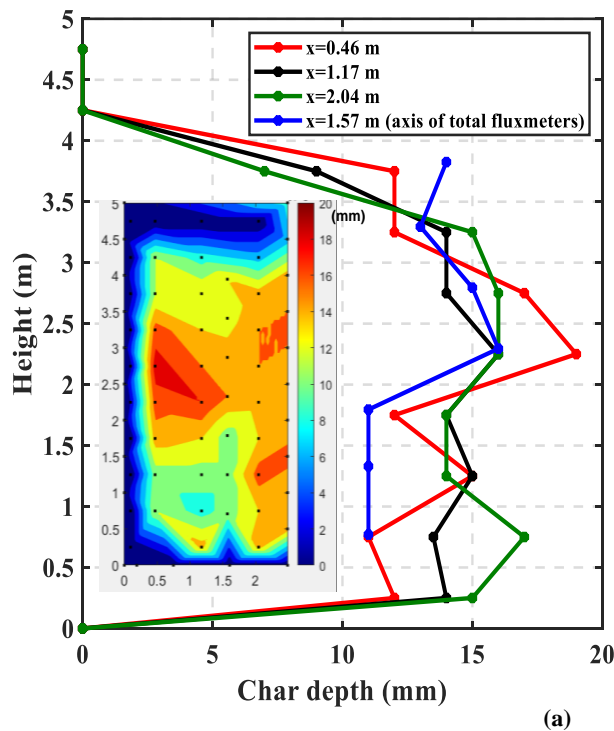
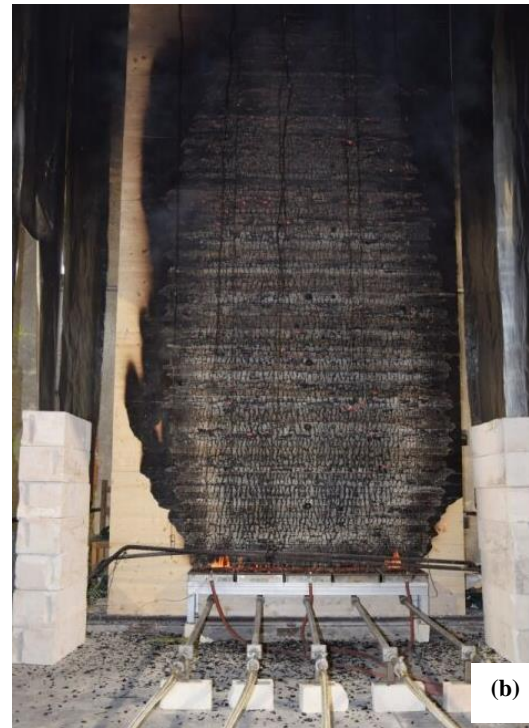
Figure 8 (a) picture after test (b) char depth distribution

After the test, the char depth was measured according to the method explained previously. Figure 8-a

shows the vertical profiles of the char depth with char depth map obtained through bilinear interpolation from measurements data as an indication. The most severe charring was found in the center right of the facade where the char depth reached approximately 18 mm. The average char depth was 11 mm corresponding to a charring rate of 0.33 mm/min. In the upper regions, char depths became negligible above a height of 4.5 m (between 0 and 1 mm). We note also that a part in the left end of the wall remained uncharred (figure 8-b) due to the position of the burner which is shifted to the right as mentioned previously.

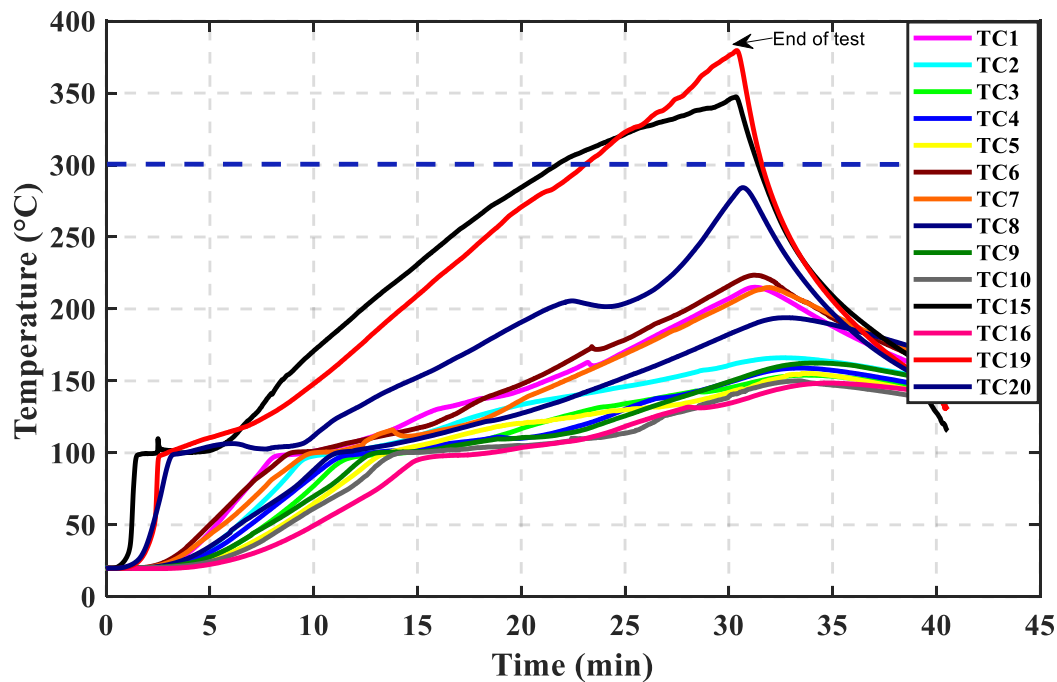
Figure 9 In-depth temperature measured by thermocouples located at 10 mm from the exposed face

Char depth can also be evaluated by the 300 °C isotherm [11]. Indeed, it is often assumed that the 300 °C isotherm is the location of the charring front. As shown in Figure 9, the temperatures recorded by the thermocouples installed into the wood 10 mm from the exposed face do not exceed 300°C except for two thermocouples. These results are therefore not in agreement with those obtained from direct measurements. This is explained by the fact that the thermocouples are installed perpendicular to the isotherms which leads to a significant underestimation of the temperature due to thermal bridging effect created by a thermocouple [12], [13], [14], [15]. It is strongly recommended that thermocouples must be embedded parallel to the isotherms to limit measurement errors. However, this technique is very difficult to implement in large panels.
