MEASUREMENT OF FRACTURE TOUGHNESS OF METALLIC MATERIALS PRODUCED BY ADDITIVE MANUFACTURING

MEASUREMENT OF FRACTURE TOUGHNESS OF METALLIC MATERIALS
PRODUCED BY ADDITIVE MANUFACTURING
27-30 September 2016, Toulouse, France

O. Quénard⁽¹⁾, O. Dorival^(1,2), Ph. Guy⁽¹⁾, A. Votie⁽³⁾, K. Brethome⁽⁴⁾

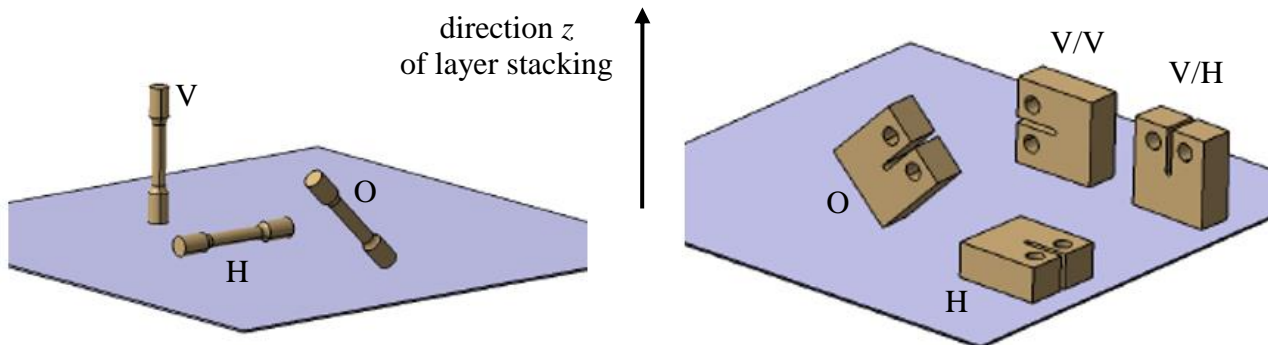
The ALM process consists in melting the part layer by layer, favouring the anisotropy of direction z of the “stacking”. Consequently, three particular orientations of the samples were identified for the tensile specimens, as shown in **Fig. 1**. Note that for tensile specimens, this direction corresponds to the loading axis: vertical (denoted by “V”), horizontal (“H”), slanted at 45° (“O”). Note that in-plane directions x and y were not distinguished since the laser advance direction is turning of 30° when changing for the next layer. For the toughness specimens however, one needs to report both

the building plane and the loading axis due to multiple crack orientations. Consequently four different orientations were identified: horizontal (resp. oblique) specimens gave only horizontal (resp. oblique) loading direction denoted by “H” (resp. “O”), whereas vertical specimens could lead to both a vertical notch and horizontal loading direction (denoted by “V/H”), and a horizontal notch and vertical direction (“V/V”).

Fig. 1 - Orientations of the samples for tensile and toughness tests

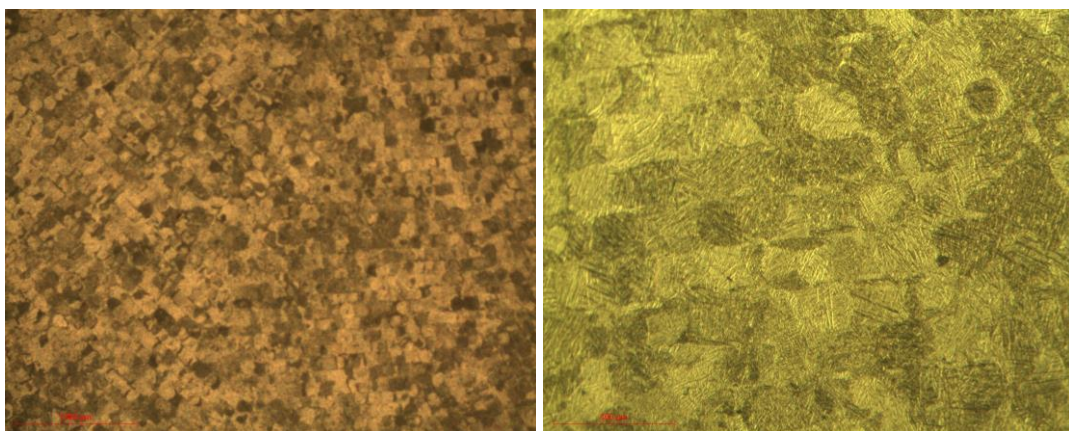
Horizontal: At low magnification, each layer is composed of lines parallel one to each other, each of them showing a succession of more or less regular squares (see **Fig. 2**). This typical microstructure reflects the successive scanning orientations of the laser beam during the manufacturing. Indeed, for each layer, the laser beam produced a melted bead and, after recrystallization, a line of solid material (the width of which is ranging between 100 and 120 μm) aligned to the direction of the laser beam displacement. The direction of the beam changing from layer to layer, and the induced fusion affecting not only the concerned layer but also the 2-3 lower layers, the recrystallization produced square grains detectable along each line. Observing several orientations of the lines indicates that the polishing affected several successive layers.

Fig. 2. Microstructure observed for the Ti-6Al-4V sample at low magnifications

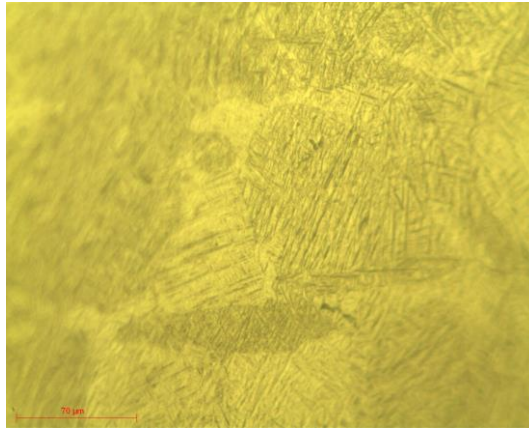
Higher magnification allows observing the martensitic structure (see **Fig. 3**) of each square of the Ti-6Al-4V sample. This microstructure indicates that the cooling rate during the manufacturing process was fast enough to lead to the α' metastable phase.

Fig. 3. Martensitic microstructure of the Ti-6Al-4V sample

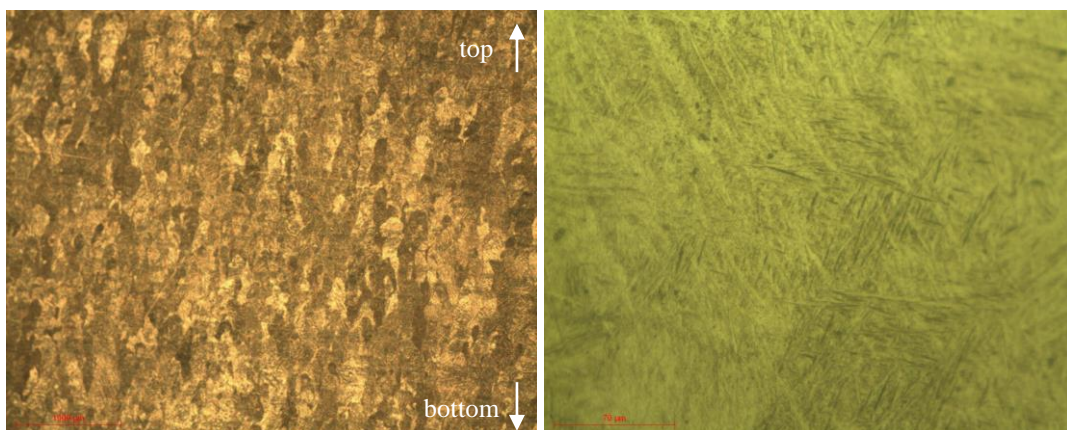
Vertical: Observations of the Ti-6Al-4V sample along its height revealed that, if the microstructure is composed of layers, the obtained grains after recrystallization have a columnar structure (see **Fig. 4**), the orientation of which is perpendicular to the layers. This microstructure is only possible by fusion of the lower layers, leading to a melted bead with a “keyhole” section when scanning the laser beam [29, 30]. **Fig. 4** confirmed that the grains are made of α' martensitic phase.

Fig. 4. Microstructure along the height of the Ti-6Al-4V sample at low (left) and high (right) magnification

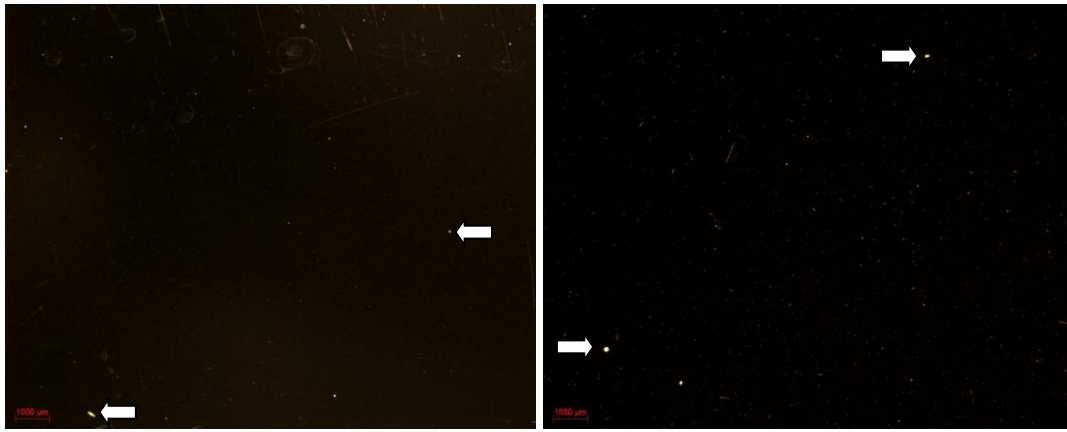
The HIP treatment was expected to eliminate, or at least reduce, the porosity rate in the obtained samples. Among all the potential techniques, we estimated the porosity rate by observing the polished surface of the sample and detect the porosity by difference of colour. The surface of the sample appears dark while porosity appears as white dots (see **Fig. 5**). As a first result, we can say that the HIP finally did not reduce the porosity rate, maybe due to the very low proportion of porosity (lower than 0.2%) in the initial material.

Fig. 5. Porosity (white dots) detected in the Ti-6Al-4V sample before (left) and after (right) the HIP treatment

Then, it appeared that there was no porosity detected on the fracture surface, proving that if there was residual porosity in the whole sample (as noted in **Fig. 5**), it had no influence on the mechanical performances of the HIPed sample. The thermal treatment seems to be very efficient to increase the plastic deformation of LBM manufactured Ti-6Al-4V.

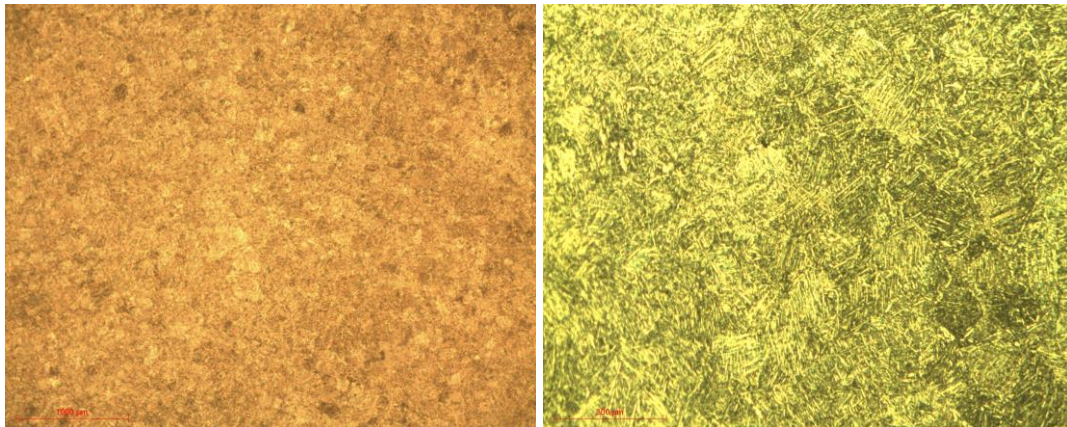
Horizontal: The HIP treatment clearly blurred the anisotropic microstructure of the Ti-6Al-4V sample (see Fig. 6), even if some residual anisotropy can be detected. The lines and squares largely vanished.

Fig. 6. Microstructure observed for the Ti-6Al-4V sample after HIP at low magnifications

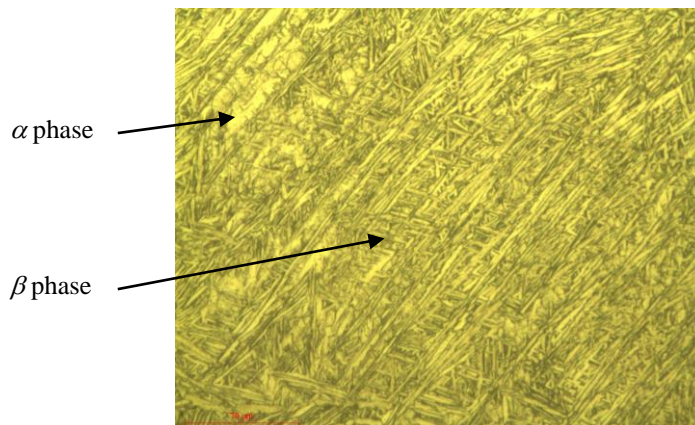
At higher magnification (see Fig. 7), observations showed that the martensitic structure disappeared; the sample is now constituted by a α/β structure. The proportion of obtained α phase is low due to a thermal treatment either at too low temperature or with a too short duration.

Fig. 7. Microstructure observed for the TA6V sample after HIP at high magnification

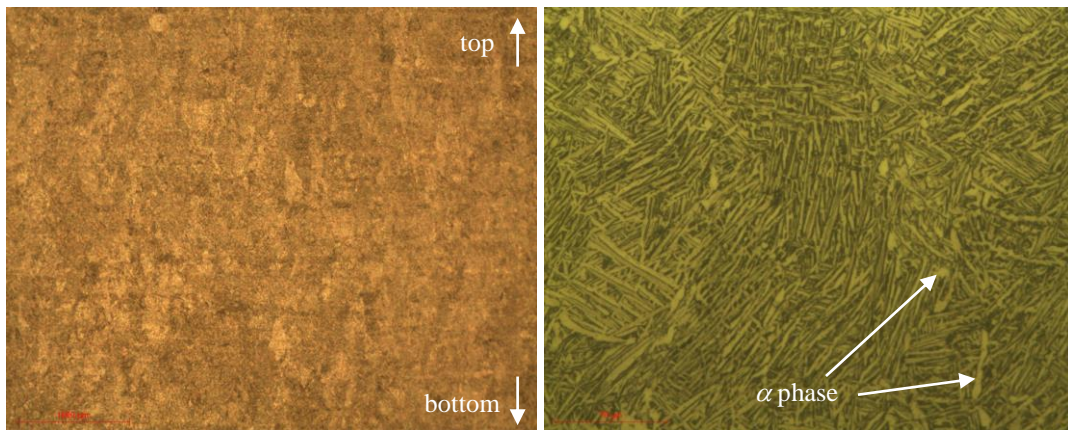
Vertical: One can note at low magnification (Fig. 8, left) that the anisotropy is not fully blurred, as layers are still slightly visible, as well as some residual columnar grains. We could then estimate that the anisotropy is more strongly present in the vertical plane than in the horizontal one. Higher

magnification (**Fig. 8**, right) allows to conclude that the α phase appears along the grain boundaries between the columnar grains, as expected.

Fig. 8. Microstructure along the height of the Ti-6Al-4V sample after HIP at low (left) and high (right) magnification

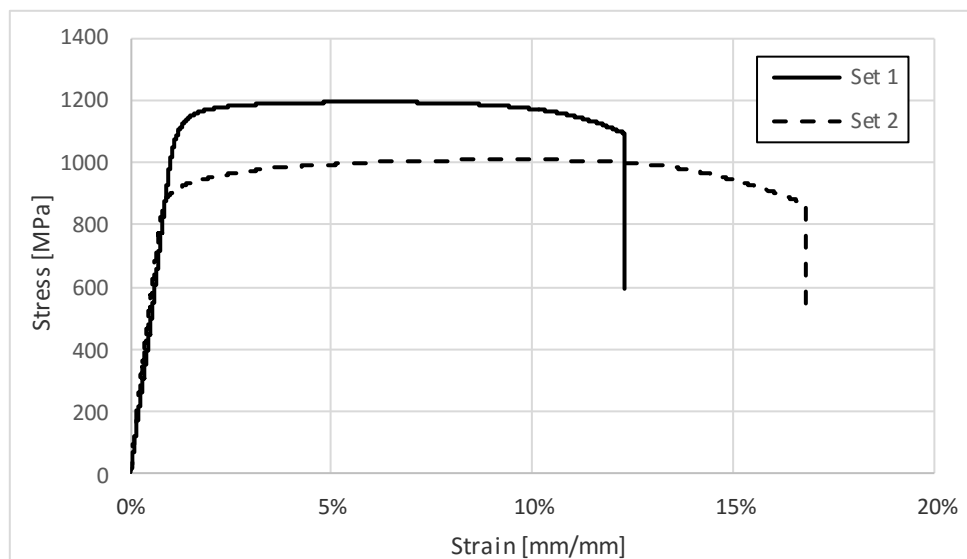
Two typical stress-strain curves obtained for samples of batches #1 and #2 are shown in **Fig. 9**. Detailed results including Young's modulus (E), tensile yield stress (YS), ultimate tensile stress (UTS) and elongation ($A\%$) for batches #1 and #2 are reported in **Table 2** and **Table 3** respectively. Unlike toughness specimen, tensile specimens did not experience cracking during the ALM process thank to more slender shape, and all specimens manufactured could be tested.

Fig. 9 - Typical stress-strain results for titanium specimen

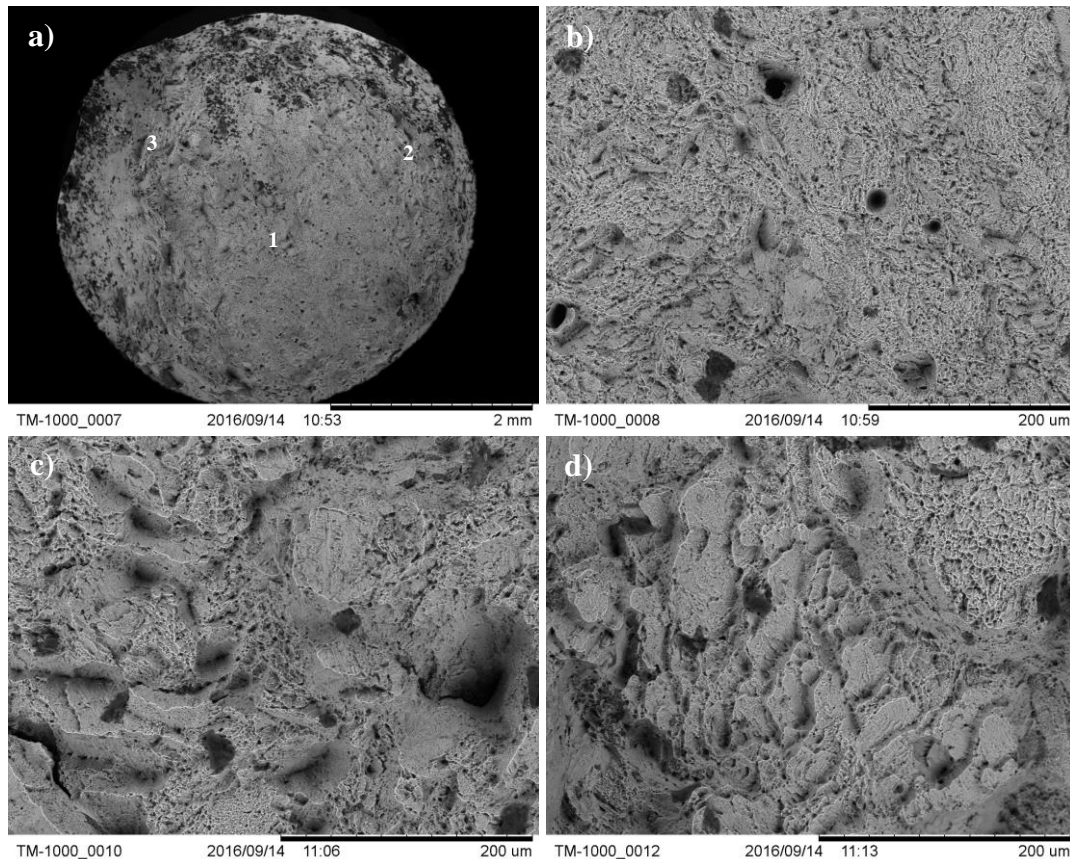
The overall view of the tensile fracture surface of the vertical as built samples is presented in **Fig. 10a**. It appears that failure mechanism was mostly ductile as a transgranular fracture surface with a network of dimples can be largely observed (see **Fig. 10b**).

Some defects can also be observed, such as porosity (resulting from microvoid coalescence during the manufacturing process), mostly located in the center part of the section of the sample (see **Fig. 10b**), even if this porosity does not seem to have a strong influence on the mechanical properties, at least for tensile tests. One could assume that the porosity could be the main cause of the fracture [13]. Nevertheless, another defect seems to have much more influence on the mechanical behaviour of the sample: the micro-cracks. They were mostly detected in the external part of the section of the sample (see **Fig. 10c**), even if few of them can be observed in the centre of the section. These micro-cracks were attributed in our case to the residual stress in the sample after the laser manufacturing, which was not erased after the stress relieving treatment. The large number of such micro-cracks at the fracture surface should underline their strong influence on the mechanical performance of the as-built Ti-6Al-4V sample. This conclusion was confirmed by the brittle surfaces detected around most of these micro-cracks, leading to cleavage facets and a layered profile (see **Fig. 10c-d**). These brittle surfaces were attributed to cleavage within layers of the material, joining two ductile surfaces, which were the interface between two successive layers. Nevertheless, in such a mixed ductile-brittle behaviour, the ductility was largely dominating.

Fig. 10. Fracture tensile surface of the vertical as built sample. (a): overall view of the fracture surface. (b): defects detected in 1 in (a). (c): microcracks detected in location 2 in (a). (d): brittle fracture surface in location 3 in (a).

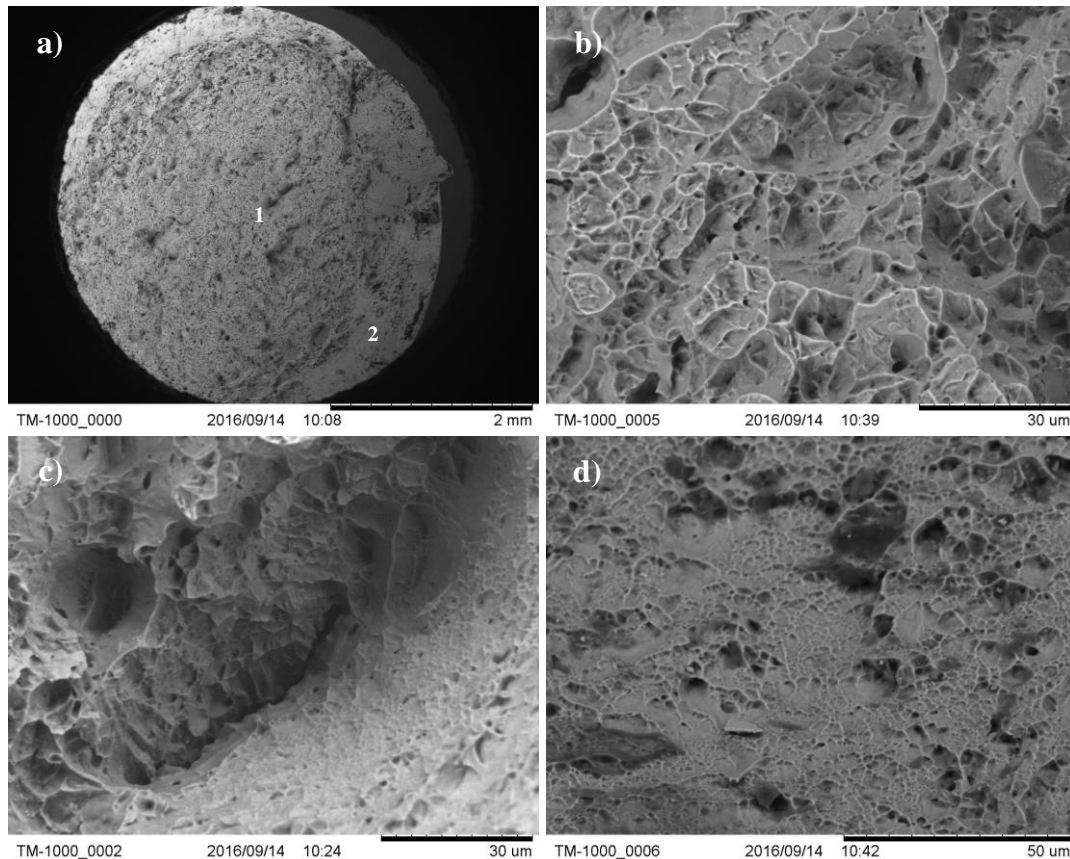
As a first result, one must note that at the lowest magnification (x40), the whole fracture surface of the vertical sample after HIP could be observed (see **Fig. 11a**), what was not possible for the as-built sample. This remark means that the HIP treatment lead to a higher ductility, and so to a larger necking, confirming the larger elongation measured for such samples during the tensile tests.

Increasing magnification during the observation allowed revealing a pure ductile behaviour of the sample, characterized by the dimples network (see **Fig. 11b**). Such a behaviour could be confirmed by both a larger necking of the sample and a “cup and cone” aspect (typical of ductile material). Some few micro-cracks were still remaining (see **Fig. 11c**), but they did not give rise to cleavage facets attributed to brittle behaviour.

The final overloaded surface (see **Fig. 11d**) also presented a ductile aspect, but the size of the dimples is much smaller. This result can be explained as the duration of final fracture was too short to allow large plastic deformation of the corresponding area, and then to lead to larger dimples. Similar results were obtained for other directions (horizontal and sidelong).

Fig. 11. Fracture tensile surface of the vertical sample after HIP treatment. (a): overall view of the fracture surface. (b): observed ductile behaviour. (c): microcrack detected in 1 in (a). (d): magnification in location 2 in (a).
