Initiation and propagation of rebar corrosion in carbonated and cracked concrete

THÈSE

Identification des phases d'initiation et de propagation de la corrosion
des armatures enrobées dans un béton fissuré et carbonaté

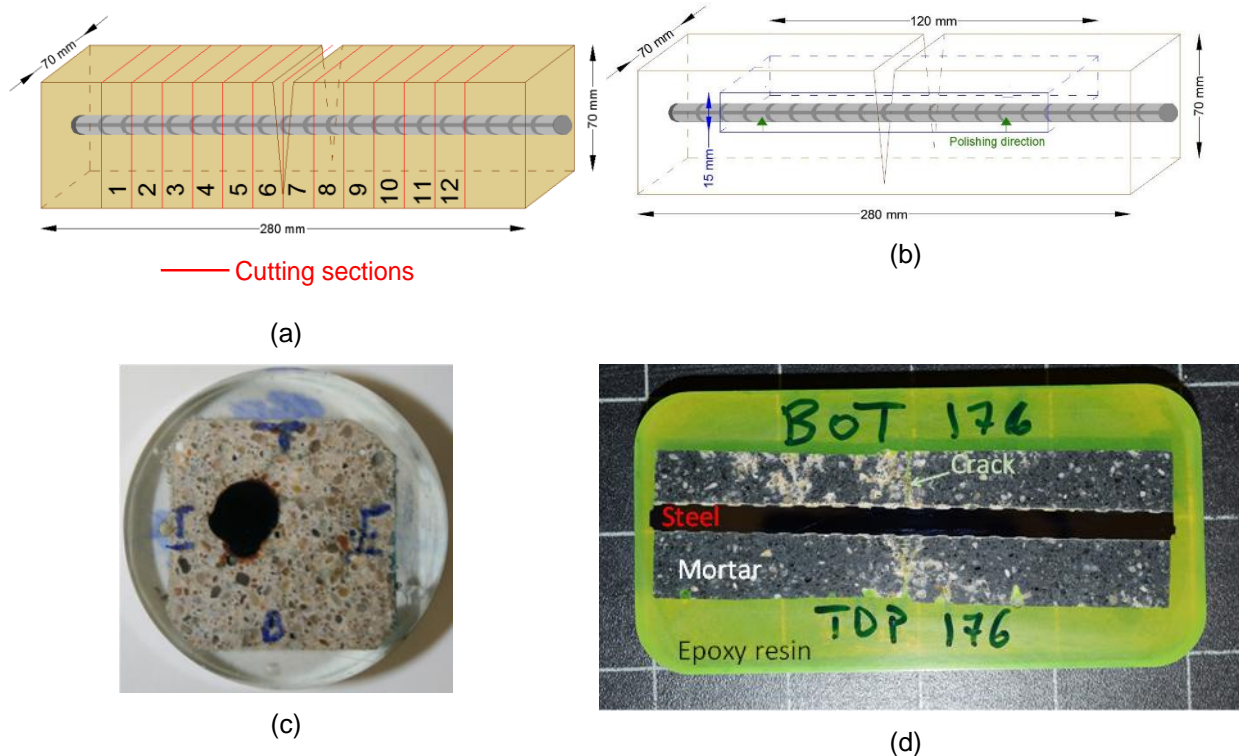
Figure 2-48: Cutting direction possibilities

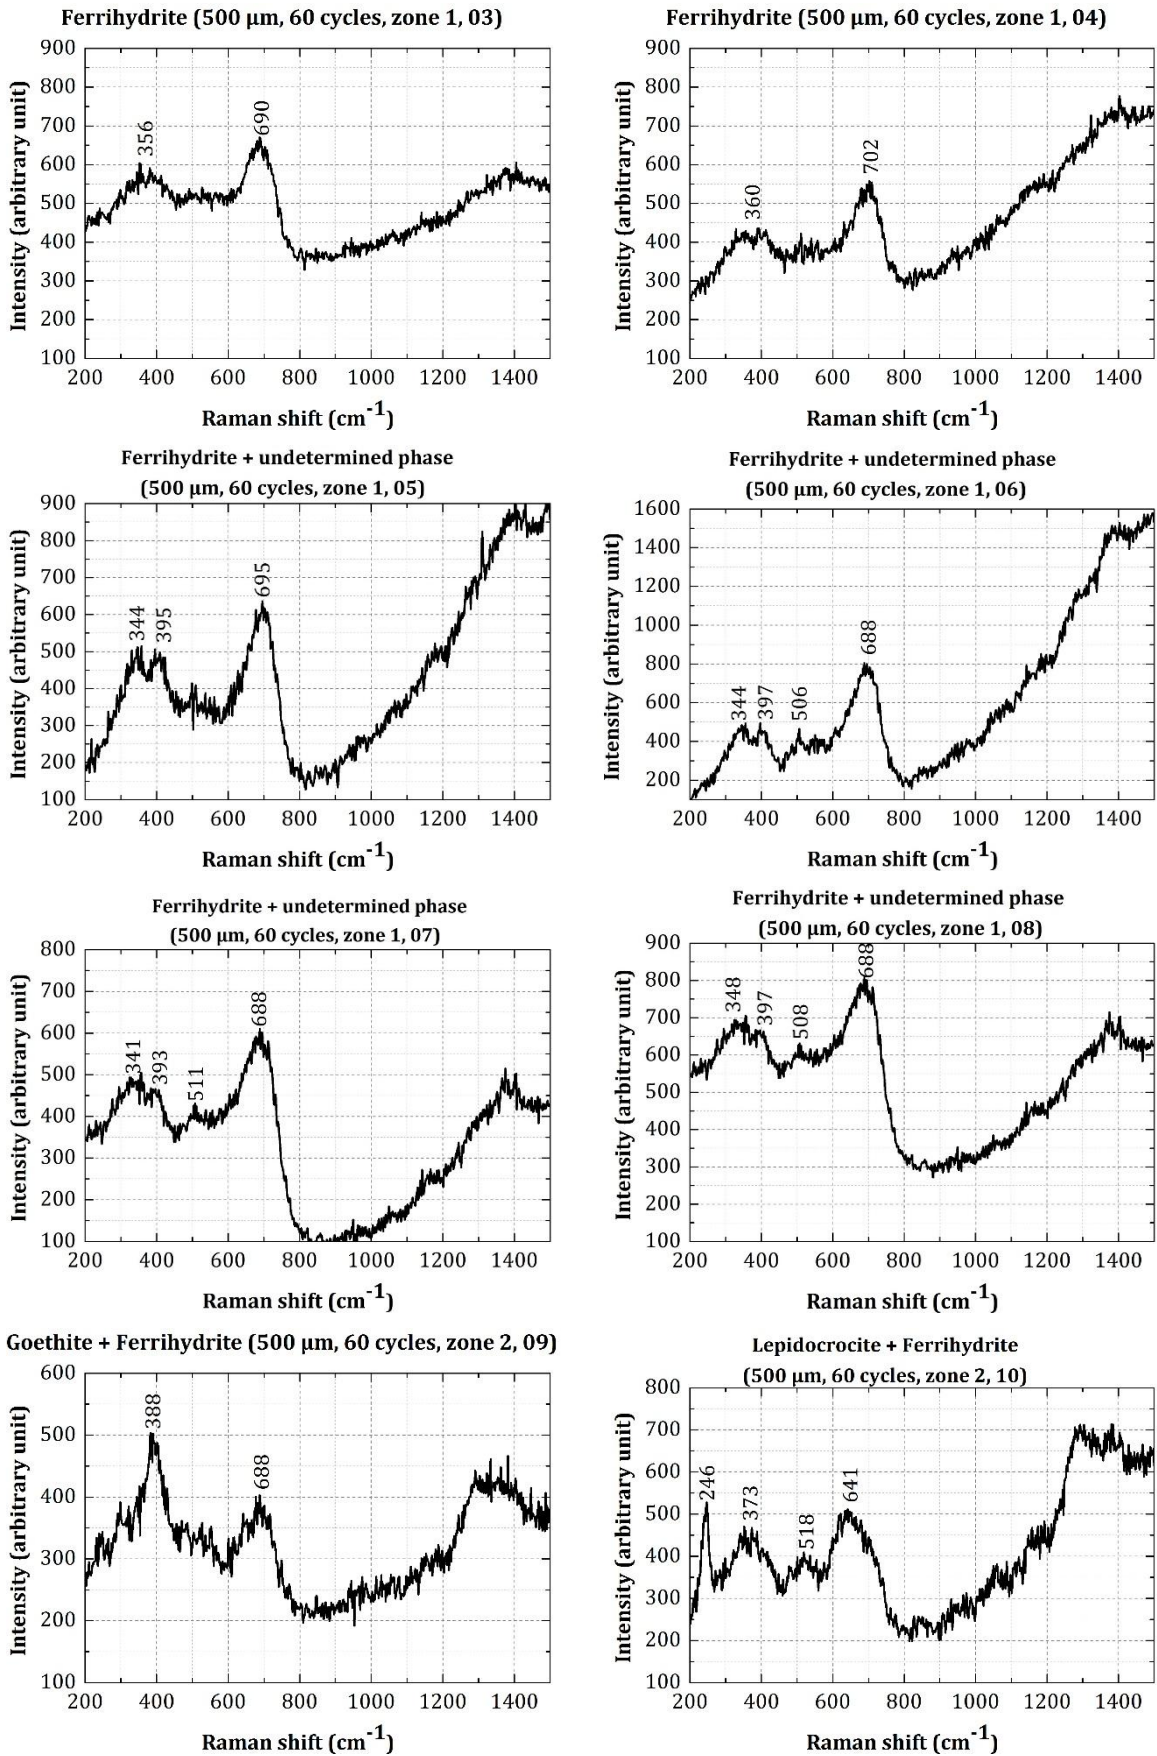
Figure 4-13 : Raman spectra of corrosion products obtained on specimens showing three different residual crack openings

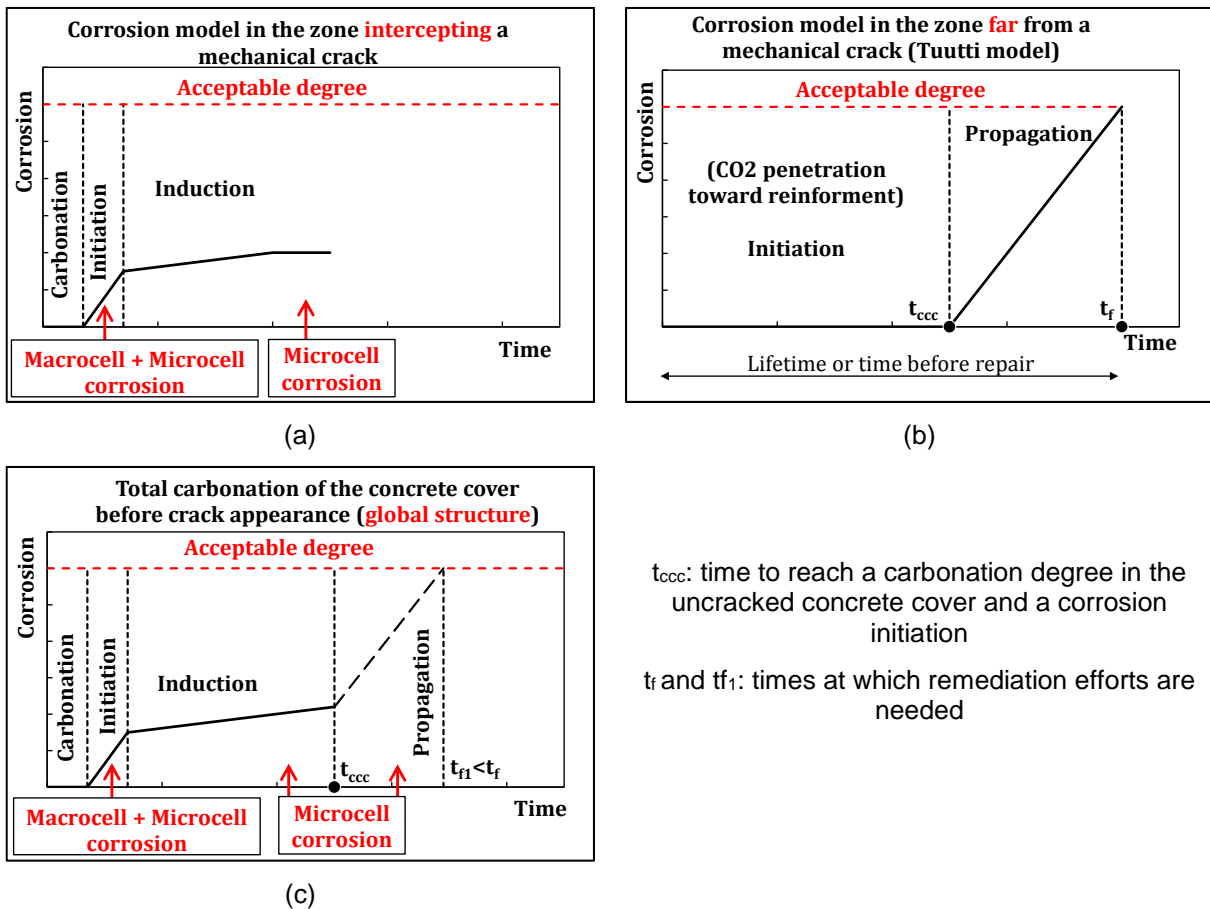
Figure 4-15: Corrosion model supposing a corrosion propagation induced by a total carbonation of the concrete cover (corresponding to the corrosion model proposed by François & Arliguie [79])

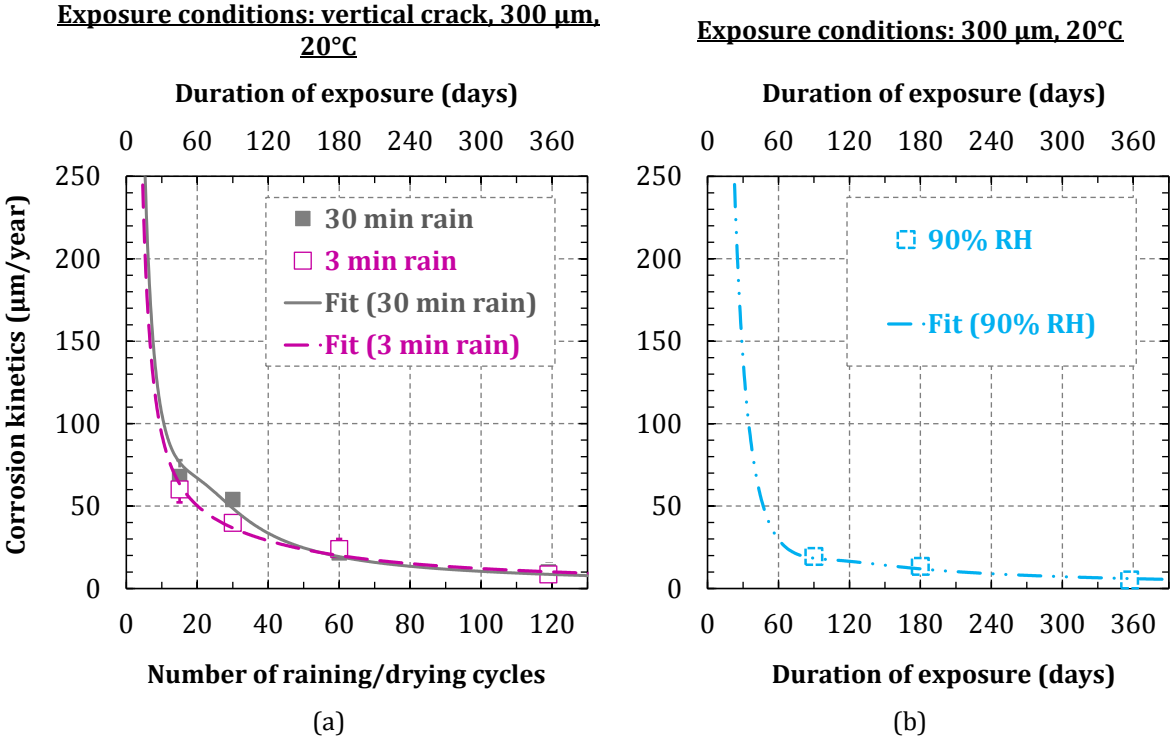
Figure 5-16: Corrosion rate evolution in specimens subject to different durations of rainfall with respect to raining/drying cycles

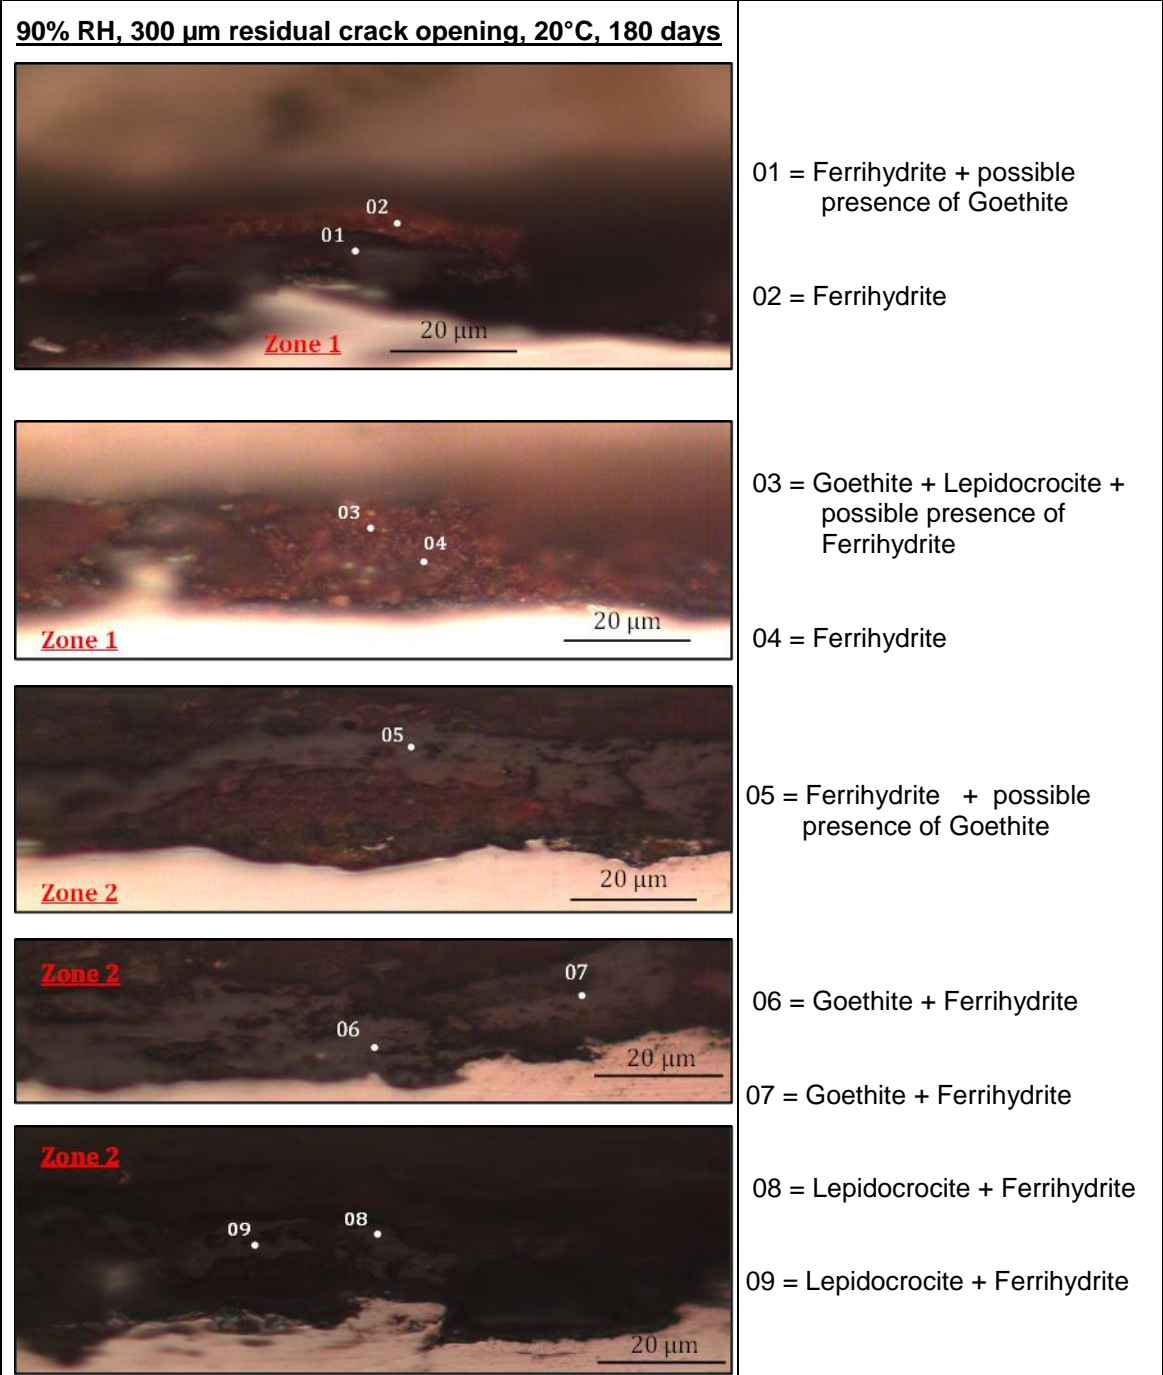
Figure 5-19: Corrosion layer observed at steel/mortar interfaces located far from the crack and deep in the crack in specimens having 300 μm residual crack width and exposed continuously to 90% RH.

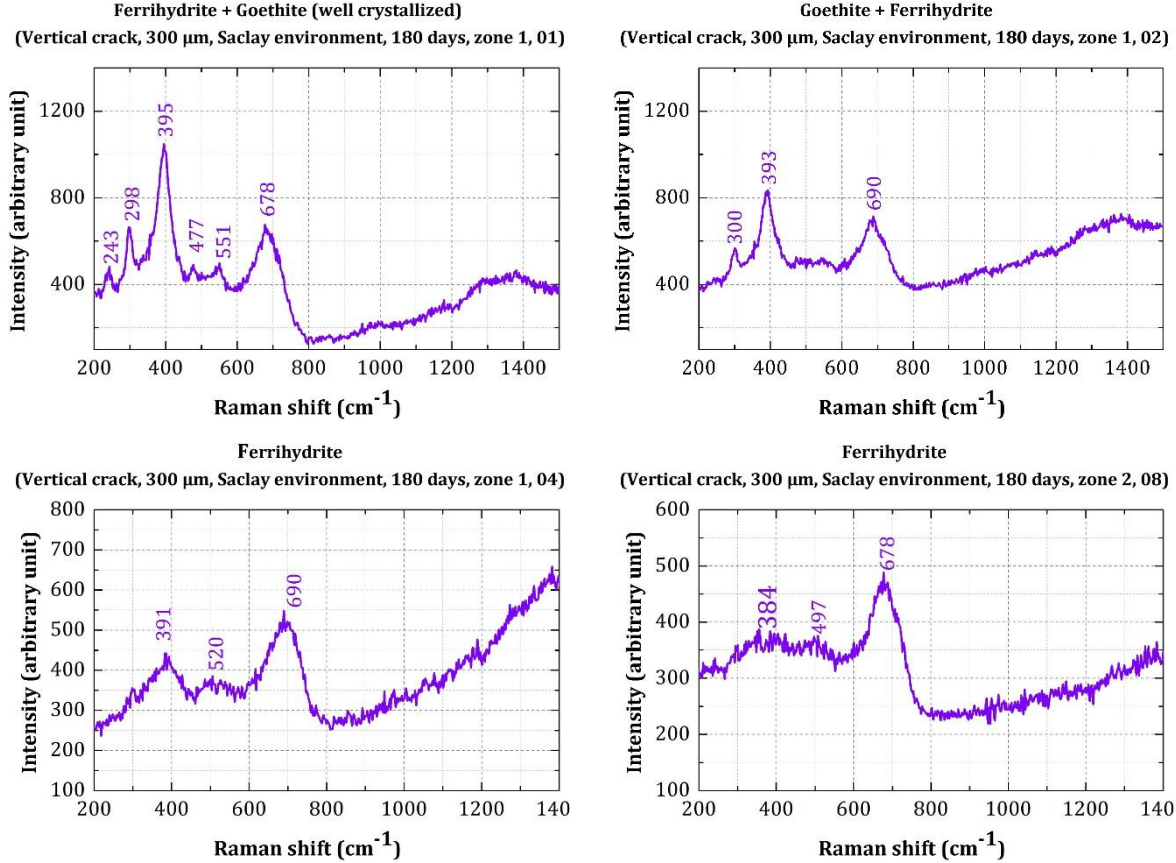
Figure 5-48: Some Raman spectra of corrosion products obtained on specimens having 300μm residual crack width and corroded in Saclay environment

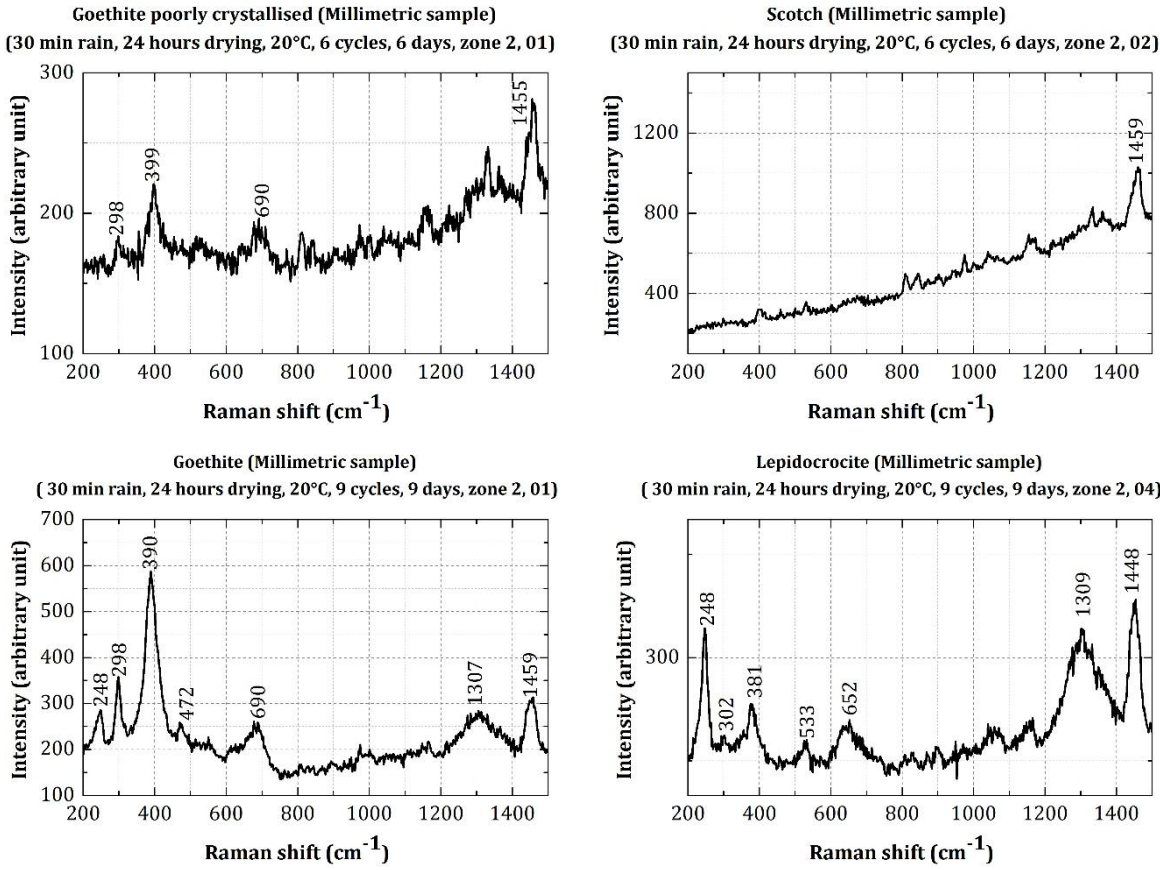
Figure 5-52: Some Raman spectra of corrosion products obtained on millimetric samples after 6 and 9 wetting/drying cycles

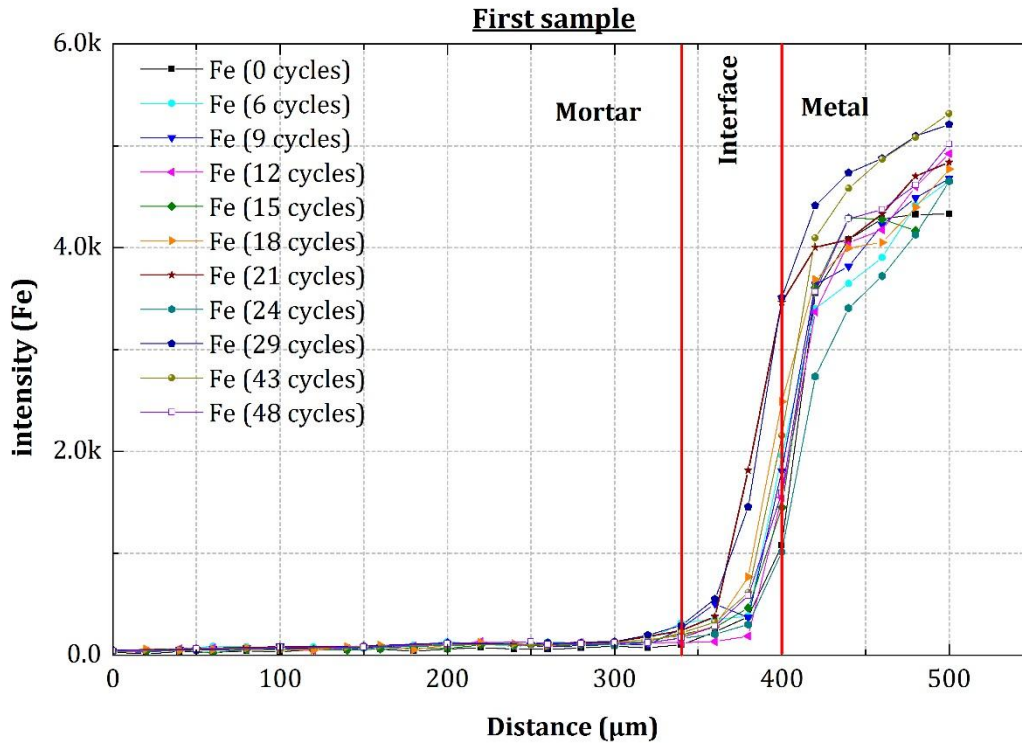
Figure I-4: Diffusion profiles of iron inside the binder obtained on millimetric sample by the X-ray

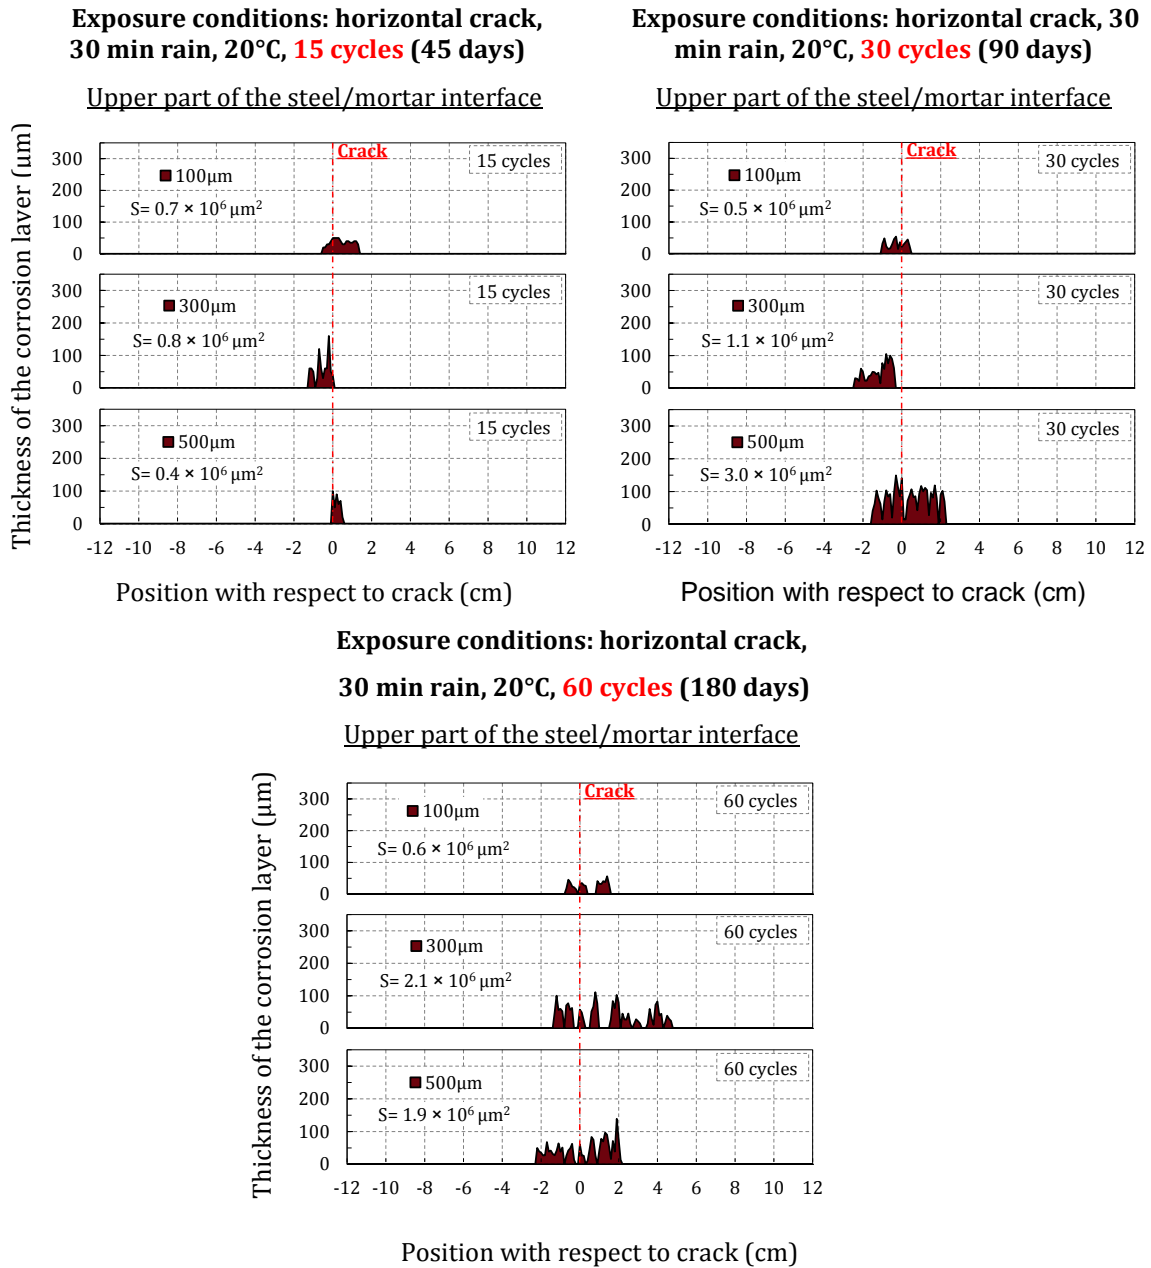
Figure I-27 : Corrosion products repartition obtained on specimens showing different residual crack openings and oriented horizontally with respect to rain

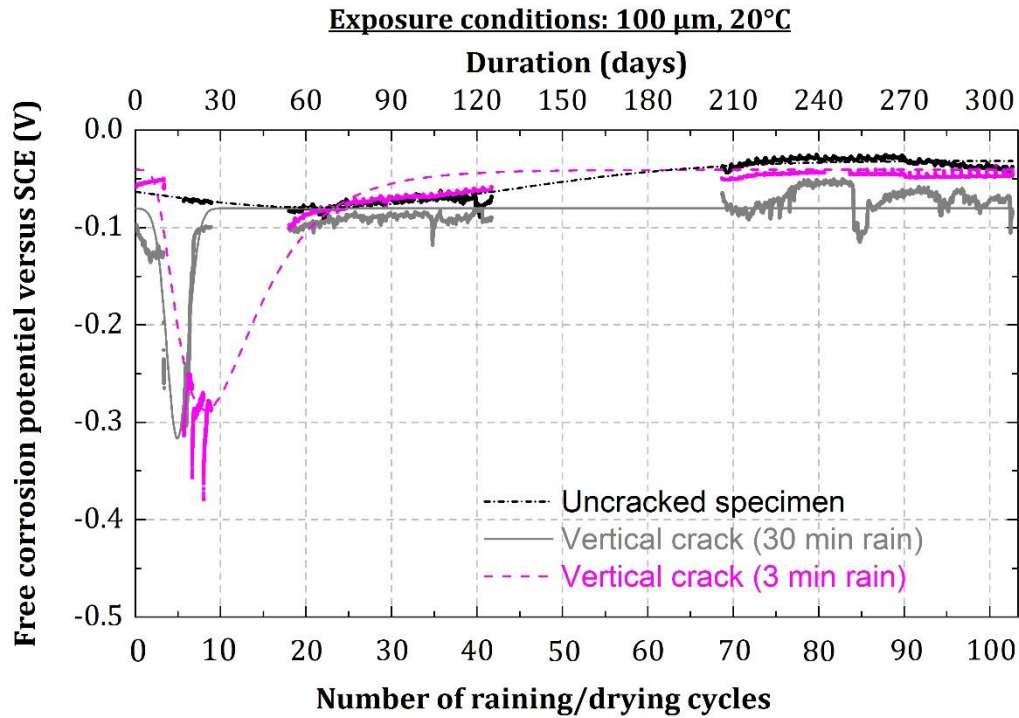
Figure I-36: Free corrosion potential (versus SCE) measured in specimens showing 100 μm residual crack width exposed to different raining durations

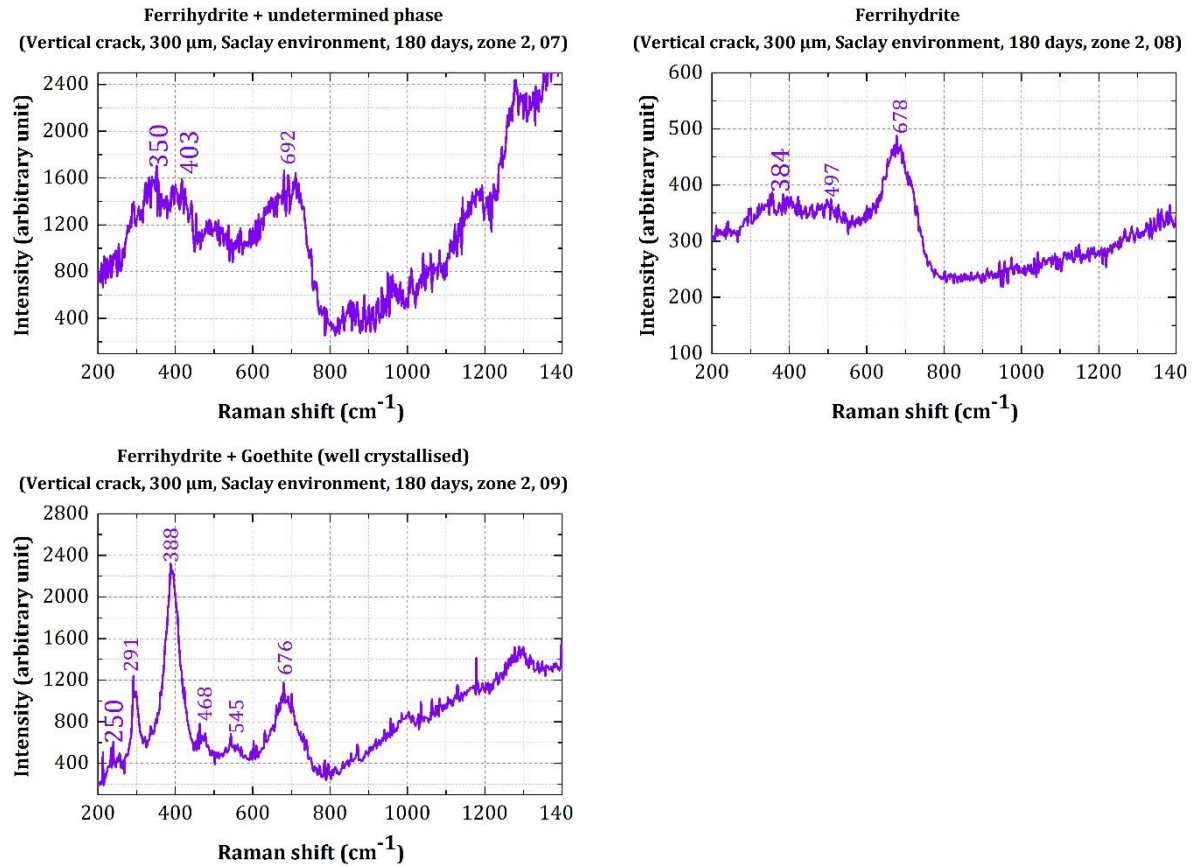
Figure I-58: All the Raman spectra of corrosion products obtained on specimens having 300 μm crack width and corroded in Saclay environment
